# Bio-engineering techniques for bank protection on the Moselle River in Villey-le-Sec

Project owner	Voies navigables de France (VNF) (French waterways)
Category	Improvement of waterways
Type of operation	Bio-engineering techniques for river-bank protection
Type of environment	Lowland rivers
Issues at stake (water, biodiversity, climate)	Good status of habitats

Start of operationx	September 2011
End of operation	December 2011
Length of river affected by the works	1,000 m

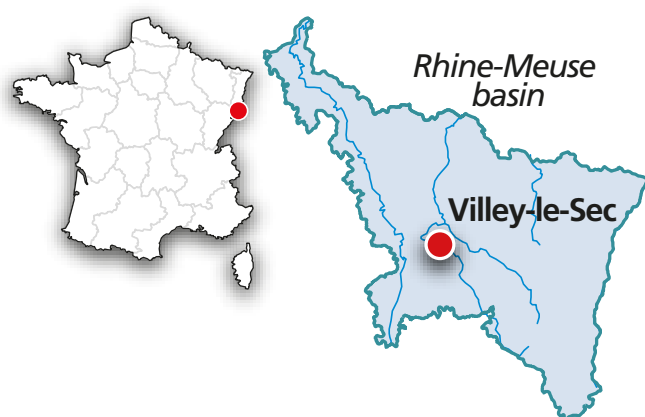
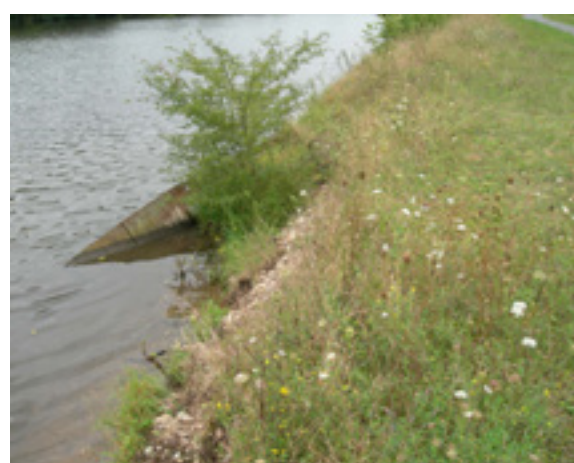
Collapse of sheet piles along 80 metres of the Moselle River. August 2008.

Following the 20-year flood in 2006, 80 metres of metal sheet piles, dating back to the work to open the Moselle to large ships, collapsed. The bank became unstable and erosion occurred at points along a 300-metre linear distance.

The sheet piles along the work site were removed. The banks were reworked over a distance of 1,000 metres and a coconut geotextile was laid. Local plant species were then planted along the banks, including helophytes (three to four plants per linear metre), willow cuttings, etc.

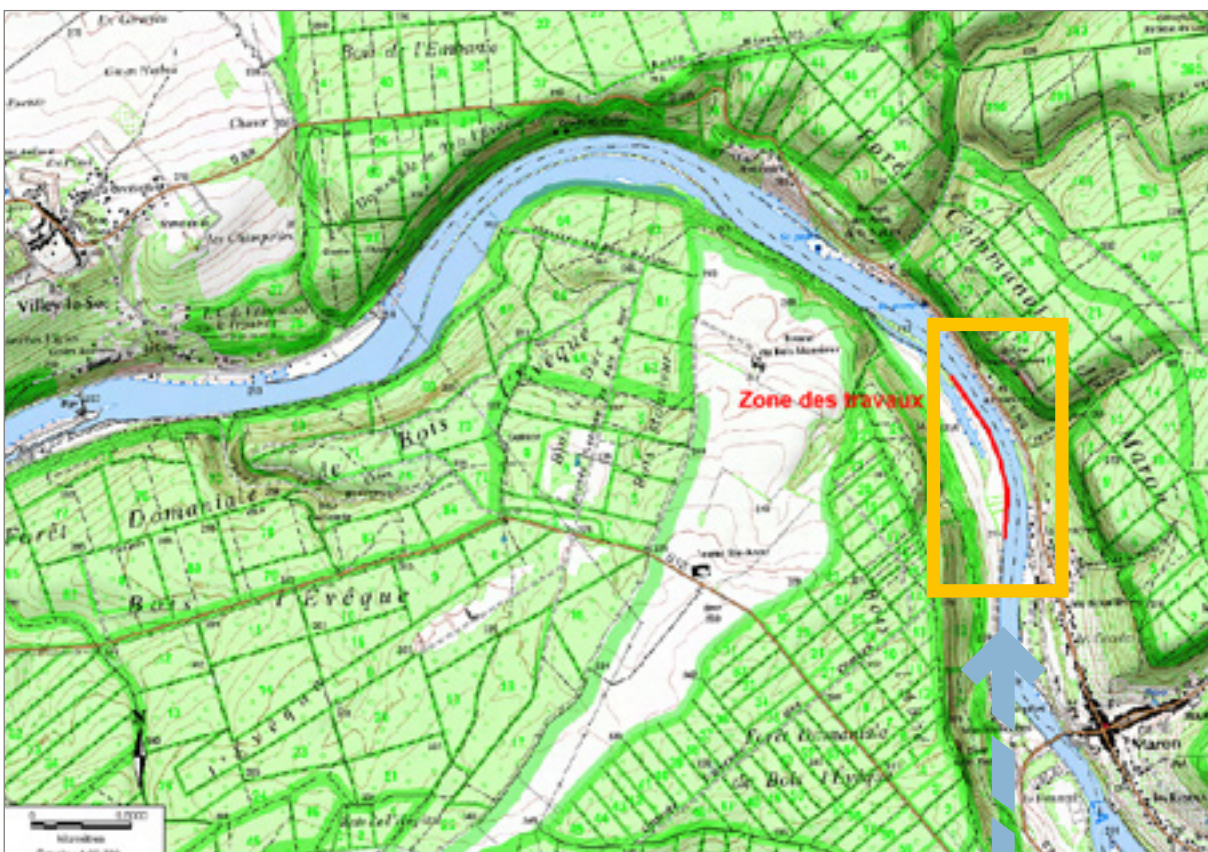
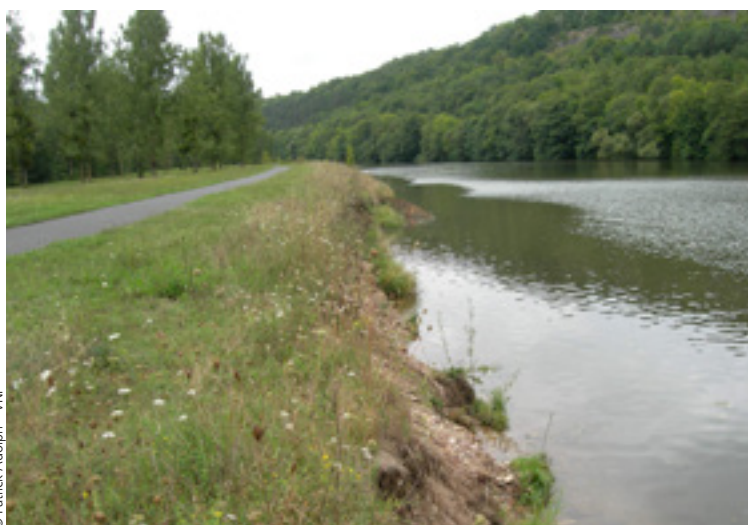
In light of the damage, an assessment of the banks was carried out by an engineering firm in 2009. The results made clear the seriousness of the situation and the risks incurred by the notches in the banks caused by the erosion. The danger was that the eroded material could be deposited in the navigation channel and the service road damaged.

Eroded sections appeared in the banks following the collapse of metal sheet piles along the Moselle River. August 2008.

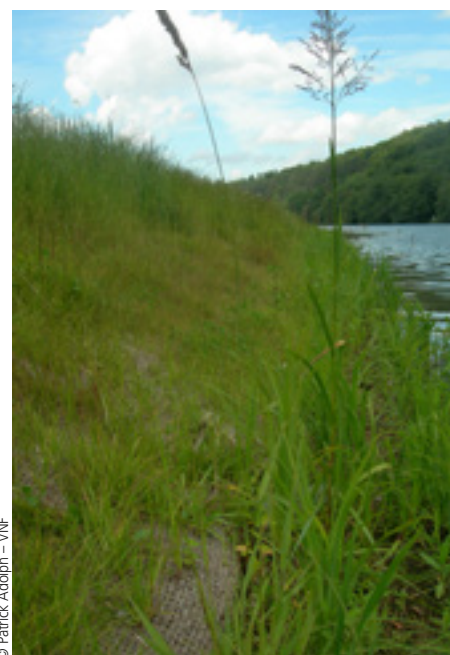
Installation of geotextiles and planting of helophytes on the banks of the Moselle River. Fall 2011.

*Voies navigables de France* plans to return to the site to make minor repairs on the geotextile and to replant helophytes where they did not develop well.

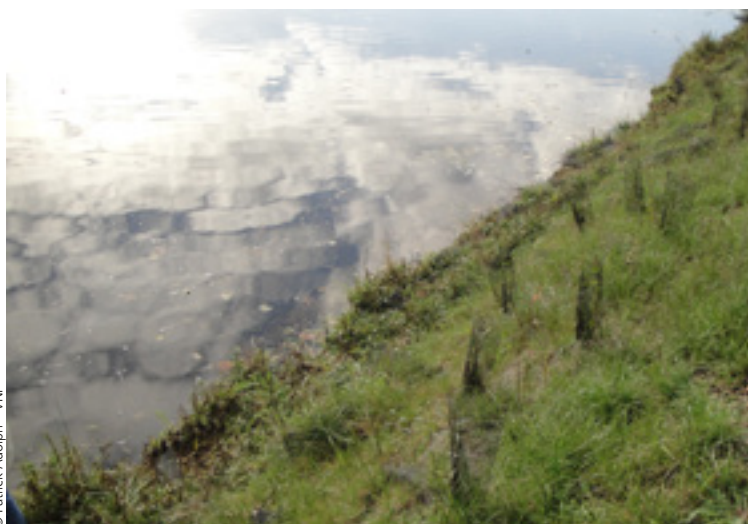
Signs of beaver activity and passage on the banks. Fall 2012.

The objective of the work was not to restore significant hydromorphological functioning, but to re-establish the lateral continuity that had been lost due to the presence of the metal sheet piles. During the monitoring visits, signs of several passages by beavers were noted, confirming the significant improvement in transverse continuity.

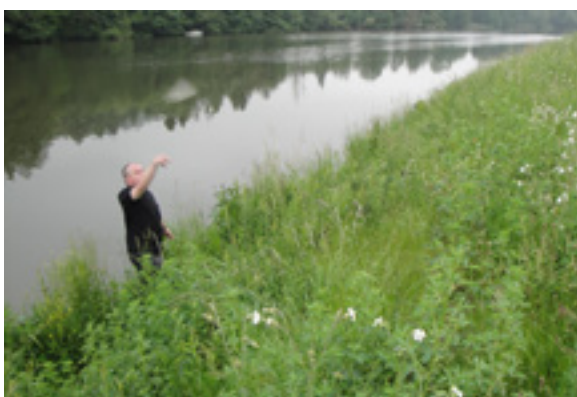
*Development of grass and bushes on the banks of the section where the work took place. June 2013.*

The monitoring in July 2013 showed improved results. A greater number of alevins were present, signalling progressive colonisation of the bank habitats. The vegetation is now firmly implanted and growing satisfactorily. Future monitoring work will indicate whether this positive trend has continued.

In addition, significant colonisation by alder trees at the foot of the bank was observed, which will require monitoring to track the future development.
