Curly Waterweed

(Lagarosiphon major)

Managing curly waterweed in the Salagou reservoir (Hérault department)

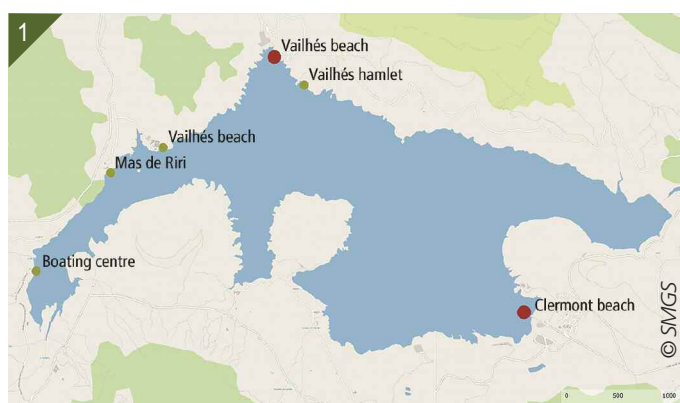
Key
 ● Mechanical harvesting
 ● Manual uprooting

1. Sites where work on curly waterweed was done in the Salagou reservoir in 2014.

- Given the size of the colonised area and the high growth rates of the plant, curly waterweed could not be eradicated. The intervention had to be adapted to the available human resources and to the technical limitations weighing on the local governments. Priorities were set, i.e. the management work focussed on the sites receiving large numbers of tourists.
- Each year, a company was hired by the town of Clermont l'Hérault and by the Lodévois et Larzac intermunicipal board to harvest the plants over respective surface areas of 10 000 (Clermont beach) and 5 000 (Vailhès bay) square metres.
- At the request of the tourism companies and the towns, volunteer work sites for manual uprooting of the plants have been organised since 2014 on beaches receiving moderate numbers of people.
- These work sites are organised by the SMGS board.

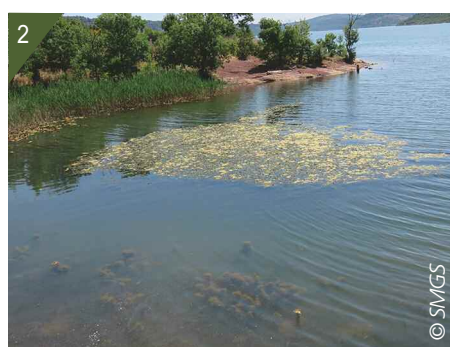
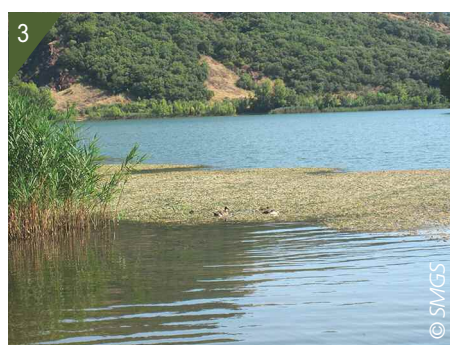
2, 3. Beds of curly waterweed in the Salagou reservoir.

conservatory in 2009. Then in 2011, the department ran an underwater inspection that revealed that the species existed virtually everywhere along the perimeter of the reservoir and was spreading rapidly. The plants grow in the water from the banks to a depth of five metres and are visible at the water surface from the spring to the fall (during the winter, the stems lie on the bottom).

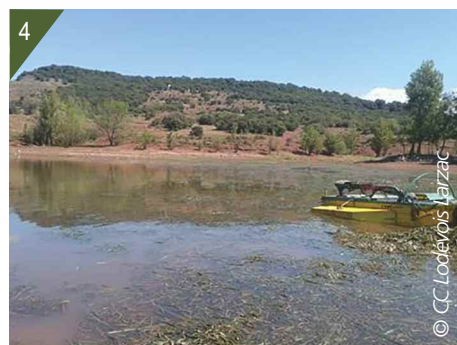
4. Harvester boat.

- This technique was used for the Clermont beach from 2013 to 2017 and in the Vailhès bay from 2013 to 2016.
- The company used a harvester boat that collects the plants immediately after they have been cut. The maximum cutting depth was three metres.
- A net was installed around the work zone to avoid the dispersal of plant fragments.
- Each year, the surface area harvested depended on the local conditions, the water level and the development of the plant beds.
- The company also handled the plant waste produced by the work. Following temporary storage to dry the plants, the waste was sent to the composting unit of the nearest civic amenity site.

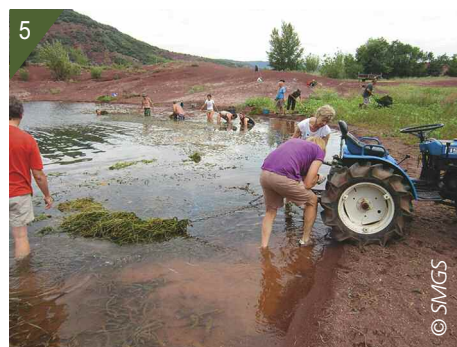
5. A test on dragging the plants using a cable.

- mechanised uprooting by running a chain or cable around a part of the bed and pulling the plants out with a four-wheel drive vehicle or a tractor.

- The technique involving setting cables from a boat is more effective and makes it possible to remove the alevins caught up in the mass of plants and to put them back into the water. For the next campaign, the plan is to uproot the curly waterweed using a winch set up on the banks. Unfortunately, this technique does not remove the entire root system with the plant.

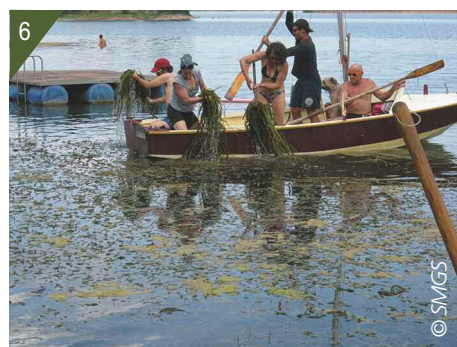
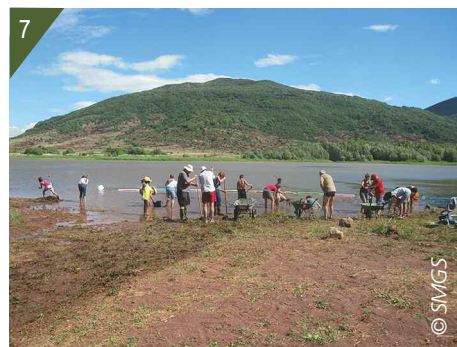
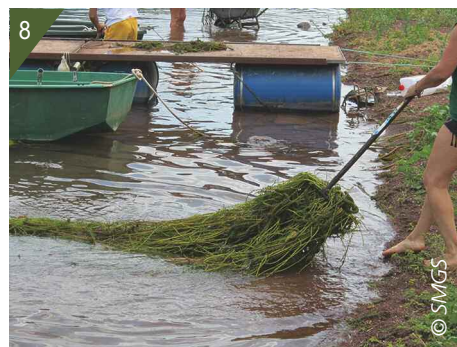
6, 7, 8. Manual uprooting by volunteers.

- Different techniques were used, depending on the configuration of each site and the available means:
 - purely manual uprooting, from the bank or in the water, to a depth accessible on foot;
 - uprooting using a rake, from the bank or in the water;
 - manual uprooting from a boat (skiff, canoe), by hand or by making circular movements in the plant bed with a rake;

- After four years of manual uprooting, it would appear that the density and vigour of the plant bed on one site harvested each year, the Mas de Riri, has declined. It should be noted, however, that this observation must be weighted against the changing weather conditions and is not confirmed by similar observations on other sites.

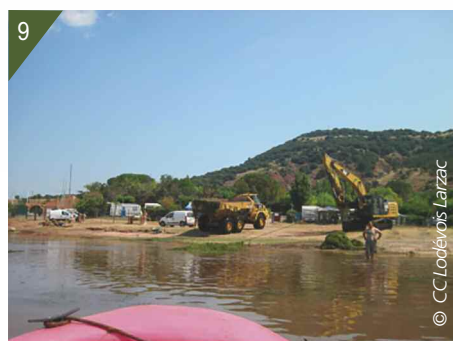
9. The excavator in action.

- When the Vailhés beach was originally created, a layer of coarse gravel was put down in the water, which later enabled the curly waterweed to take root. The project was therefore to scrape the layer of gravel in order to remove the curly waterweed and its root system.

- The work was done from the bank by an excavator equipped with a special scraper blade. The collected plants were placed in a dumper. The plants were initially deposited near the reservoir to dry and were then sent to a nearby field, owned by the town of Lodève, for composting.

- The technique used to manage the curly waterweed in the Vailhés bay using an excavator could be significantly improved. The yield in terms of plants is low when the density of curly waterweed is low and the work is limited to the depth of water accessible to “terrestrial” equipment.

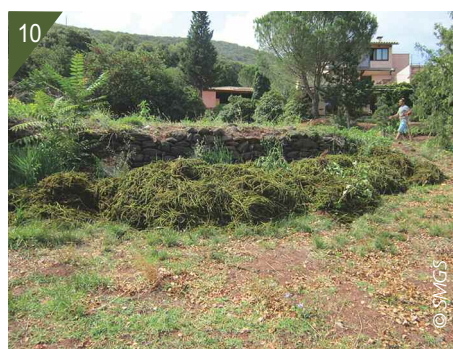
10. Curly waterweed deposited to dry.

- The plant waste produced by the work was composted on site, on dry surfaces and at a distance of at least five metres from the reservoir.
