# Water primrose

## Managing water-primrose colonisation of a canal in the Grande Brière Mottière marshes

### Brière regional nature park

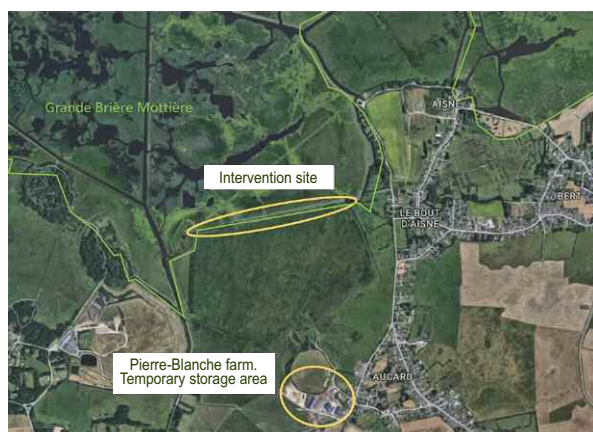
Intervention site. The lighter green areas in the meadows are the water primrose.

- The water primrose was present in abundance in and along the canal. Over a distance of 700 metres, it occupied over 90% of the water surface area and over the remaining 150 metres, it covered an area one to two metres wide along each bank. It had also invaded the nearby meadows and water bodies.

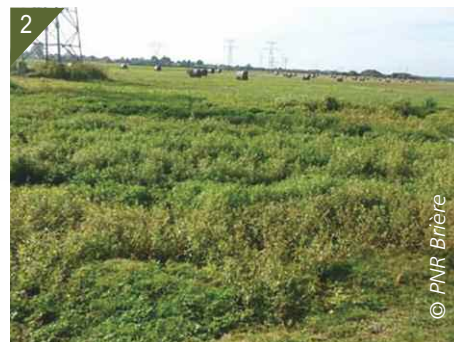
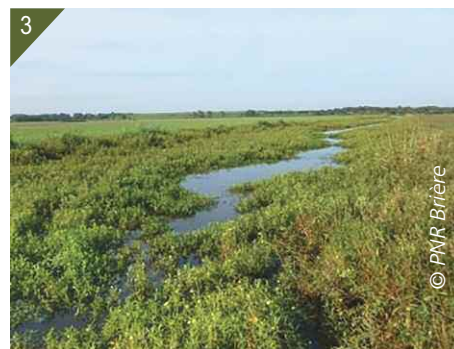
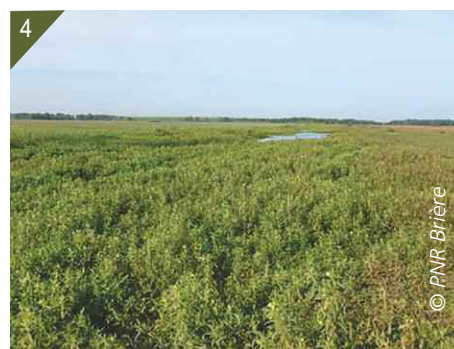
2. 3. 4. Canal full of water primrose prior to the work.

- The work took place from 15 September to 2 October 2015 in order to take advantage of the better (drier) soil conditions.
- The plants were uprooted by an excavator equipped with wide treads and a special fork designed to limit the extraction of sediment and water.
- The work did not address the beds on the top of the banks or the mud at the bottom of the canal. Their removal would have involved additional quantities of soil and sediment, as well as excess costs and regulatory constraints imposed by the Water law.

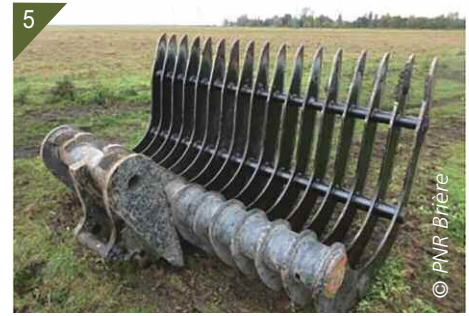
5. The fork used to uproot the plants.  
 6. Temporary storage of the water primrose, surrounded by hay.  
 7. Removal of the water primrose.  
 8. Barrier across the canal to filter fragments.
