# Giant cane

## Experiment on a mechanical technique to rapidly eliminate giant cane

### Board for the Hérault River basin (SMBFH)

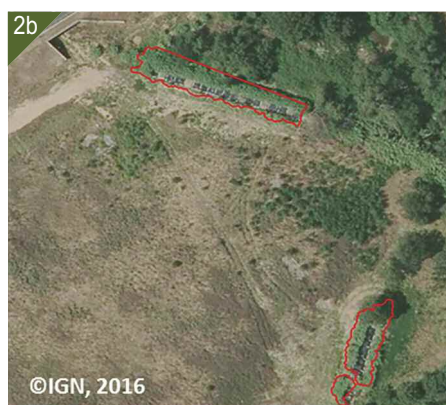
1. Map showing the site.  
2a. 2b. Aerial photos of the site before (2014) and after (2016) the work.

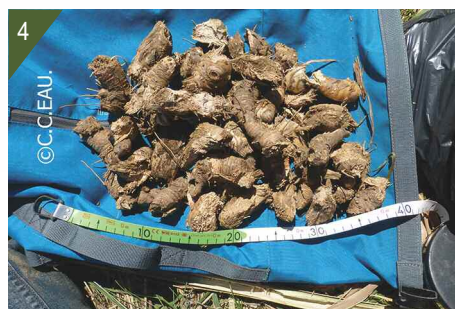
4. Fragmented rhizomes following the first passage of the grinder. Average length = 6.3 cm (SD = 2 cm, N = 150).
5. Clearing the plots using a flail-cutter set up on an excavator.
6. Removal of plant waste after clearing.
7. Soil grinding using a stone grinder mounted on a tractor.
8. Tarped, experimental plots.

- The three pedological trenches revealed:
  - an undulating layer of thick, caespitose rhizomes located at depths of up to 30 cm below the plant litter;
  - a fine and very dense root system descending to the saturated zone located approximately four metres below the ground level of the site.
- Following removal of the plant litter, the soil was ground three times to a depth of between 25 and 30 cm. In each case presented here involving grinding, it succeeded in fragmenting the rhizome layer.

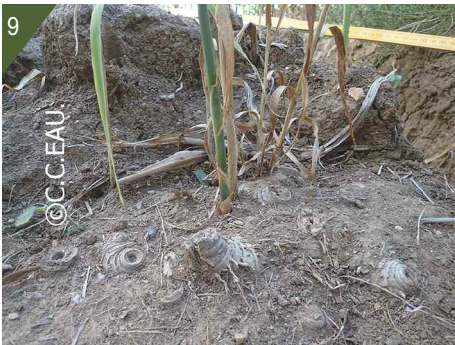
9. After 11 months of tarping, the rhizomes were still alive in a plot that had not been ground.  
10. Dead rhizomes collected in the experimental plots after six months of tarping.

- The plant was still alive after tarping of non-ground plots for 11 months.
