## Water primrose (*Ludwigia* spp.)

### Uprooting work on water primrose in the port of Biganos (Gironde department)

#### Arcachon Bay Board (SIBA)

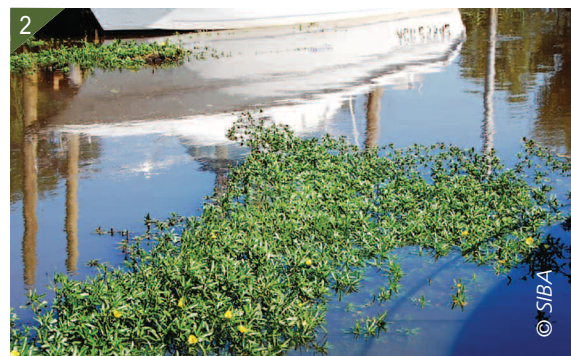
1. Map showing the site.  
2. A bed of primrose in the port of Biganos.

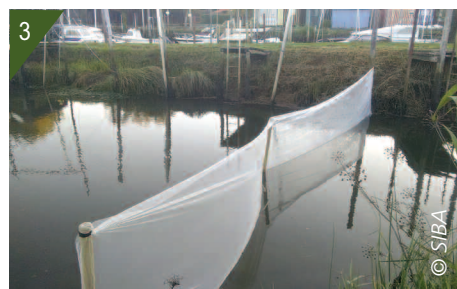
3. The net intended to prevent dispersal.

■ A net (mosquito netting) was placed at the entry of the central section. It spanned the entire width of the section (ten metres) and also blocked off a bed of water primrose detected near the entry. Two small boats were positioned in the colonised area while the tide was dropping. They served to collect the uprooted plants that were far from the banks. The boats rested on the bottom until the tide came back in and they could be moved for unloading.

■ The use of the net to avoid dispersal was not satisfactory because the wind hindered its effectiveness. A system of floats and weights may be more effective and would adapt to the changing water level due to the tides.

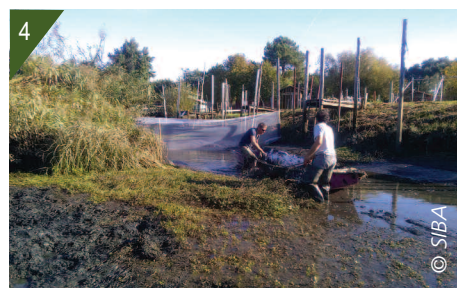
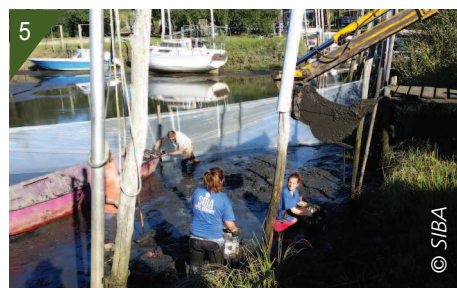
4, 5. Manual uprooting of water primrose in the central section.

■ The uprooting was done by hand, using rakes and garden forks. The plants were placed in oyster baskets or directly in the boats.

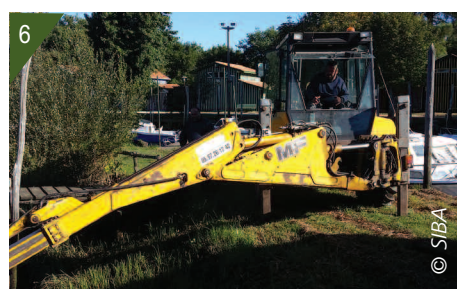
6. The backhoe loader operating from the bank.

■ In the middle of the first morning, the boats were already full and it turned out that the weight of the plants was so great that the tide could not lift the boats. A backhoe loader was then made available by the technical department of the town. The loader was positioned on the bank and the bucket was filled manually, then emptied into a dump truck or on a geotextile fabric laid out on the bank.

■ Subsequently, the loader was used directly to remove the largest beds of plants, which also resulted in the removal of large quantities of sediment.

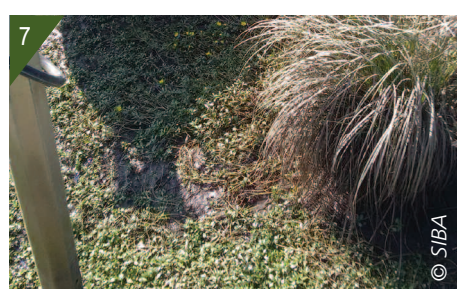
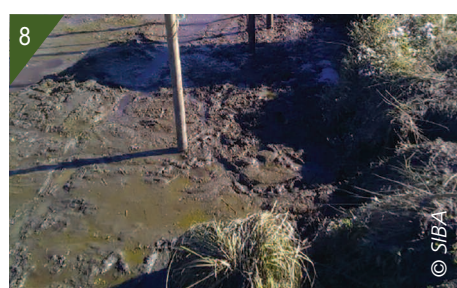
7, 8. A bed of water primrose at low tide (7) and following the work (8).

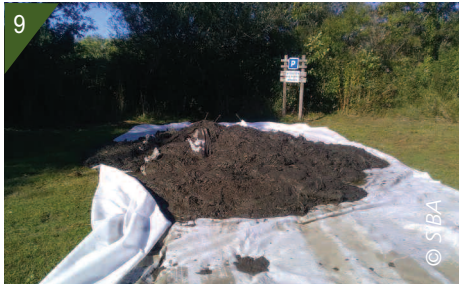
9. Storage and drying area for the uprooted plants.

■ The unloading zone for the water primrose was located near a parking lot, on land well above the high-tide mark. The uprooted plants were drained of water on the geotextile fabric and then transported to the town technical centre. After drying in a blocked off area of the technical centre, they were transported to composting units with other waste from the town.

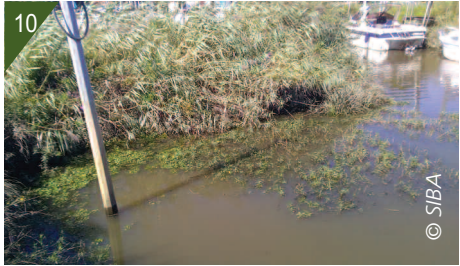
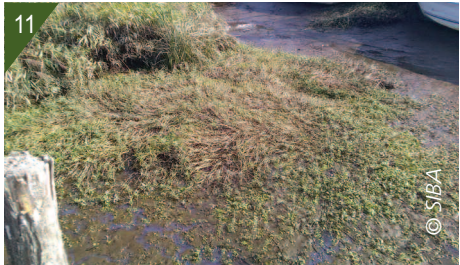
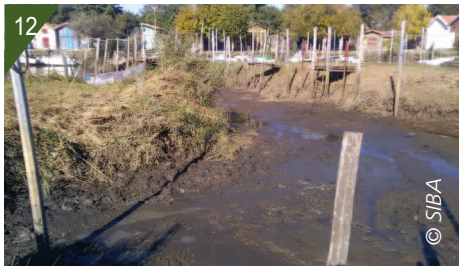
10, 11, 12. A bed of water primrose at high tide (10), at low tide (11) and following the work (12).
