New Zealand pigmyweed

Managing colonisation of a town pond by New Zealand pigmyweed in Luré (Loire department)

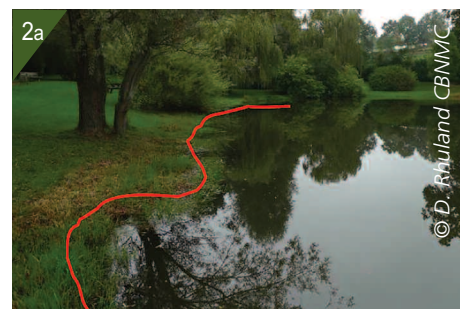
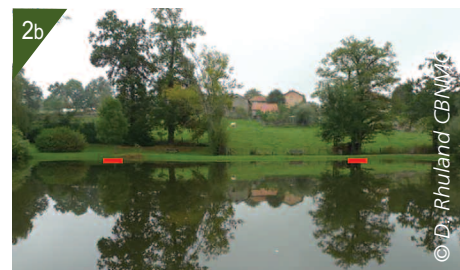
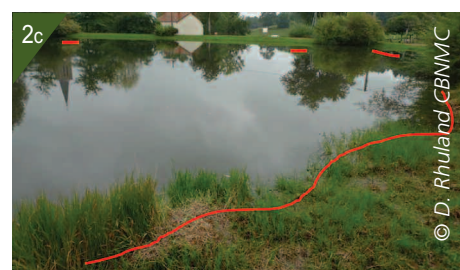
2a, b and c. Red lines showing the position of the pigmyweed in the pond on 2014.
3a and b. Filters installed in the ditch (a) and the wash house (b).

■ The CBNMC first observed *Crassula helmsii* in the pond in 2006. The plants progressively colonised the edge of the pond, spreading from approximately 5 square metres in 2013 to over 350 square metres in 2017.

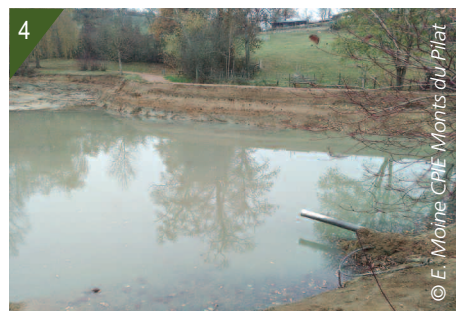
4. The pond during emptying.

■ Complete draining of the pond

■ To avoid clogging the filters and maintain their filtering capacity, the discharge rate during emptying was kept to a low level. The fish in the pond were caught with nets and taken to the local rendering service. Boots and fishing equipment were cleaned after use.

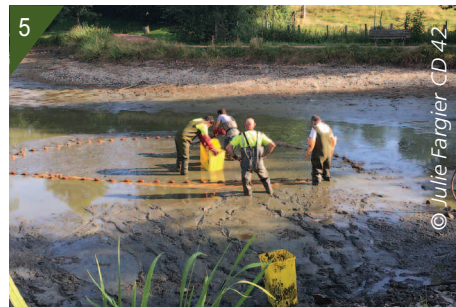
5. Removal of the fish from the pond.

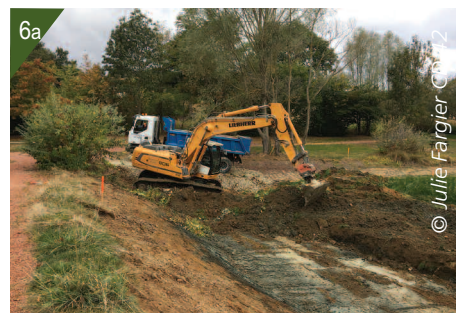
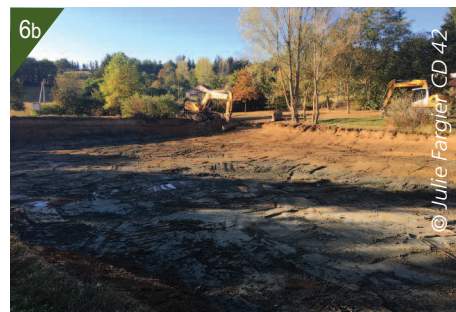
6a and b. Dredging.

■ The pond and the edges where the species was present were dredged to a depth of 50 to 70 centimetres. The input culvert to the pond was also cleaned.

■ The work was carried out by a private company and involved two tracked excavators and a dump truck for six days. The movements of the machines were precisely determined and the dredging took place from the outer edges to the middle to avoid dispersal of the pigmyweed.

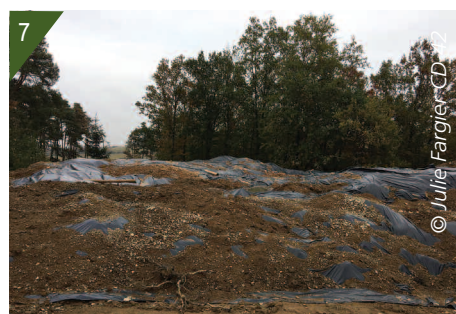
7. Mound of extracted soil.
8. The emptied pond.
9. The pond after the work.

■ A total of 1 000 cubic metres of soil potentially containing fragments of pigmyweed were removed. The entire area colonised by the pigmyweed was cleaned.
