Water fern

Manual uprooting to eradicate water fern from the Coste pond (Côtes d'Armor department)

Saint-Brieuc Armor Urban Area (SBAA)

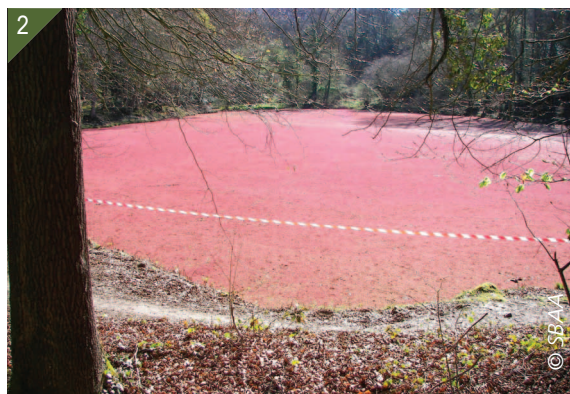
- The water fern had grown very densely and covered the entire pond, with in addition a significant layer of dead stems under the water surface.

1. The Coste pond (red circle) and the reservoir behind the Saint-Barthélemy dam (blue circle).
2. The pond entirely covered by water fern.

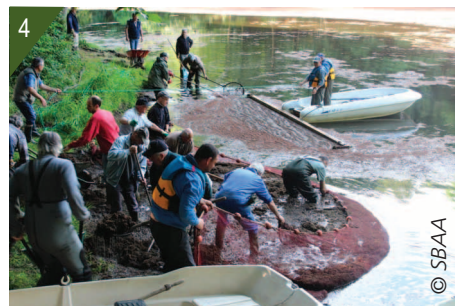
4. Net full of water fern, pulled up on the bank.

■ Using dip nets and nets with a one-centimetre mesh, the beds of water fern were gathered and pulled to the banks. Boats were used to access the centre of the pond.

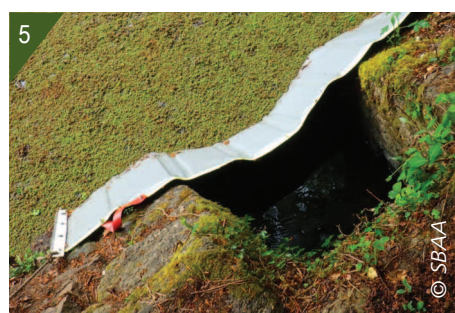
5. Barrier used to avoid the dispersal of water fern.

■ Prior to the work and to avoid any risk of dispersal downstream, a siphon was installed at the outlet of the pond, with a floating barrier of the type used to contain hydrocarbon pollutants in water.

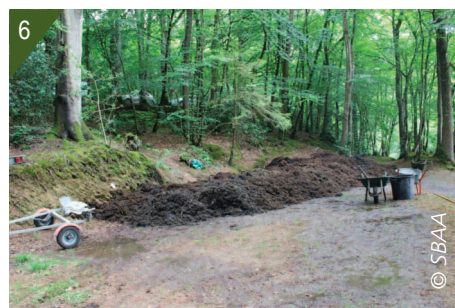
6. Swath of water fern for draining and drying prior to transport.

■ The collected water fern was laid out in swaths near the pond to drain and then transported to a disposal centre at the end of the summer and folded into a compost-production line (in the “green algae” circuit where it is first dried before being mixed with standard green waste).

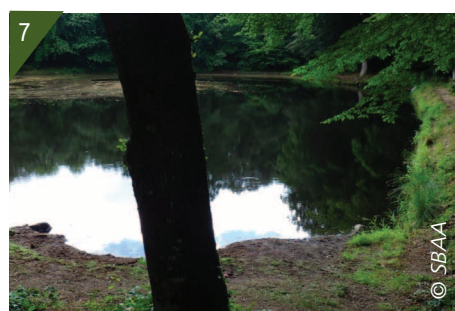
7. The pond the day after the work.

■ In July 2016, the work covered the entire pond and approximately 50 cubic metres of water fern were removed from the water, drained, dried and transported. With the exception of the small, isolated section to the north of the pond discovered in August 2016, no further discoveries of water fern were reported during the inspections.

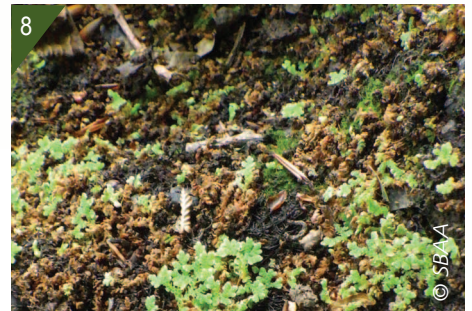
8. The small group of water-fern plants found to the north of the pond in August 2016.

■ In the beginning of August 2016, approximately one month after the work, the technician in charge of inspecting the site found some water fern growing on about 2.2 square metres of wetland (saturated soil comprising mud and sand) to the north of the pond, just a few metres from the water. With the help of the president of the hunting society and using a shovel, the technician carefully scrapped up the plants, starting from the outside and working in to avoid missing or dispersing any fragments. This additional work took approximately one hour. The removed water fern was transported in a plastic garbage bag and added to the swath of water fern collected in July.

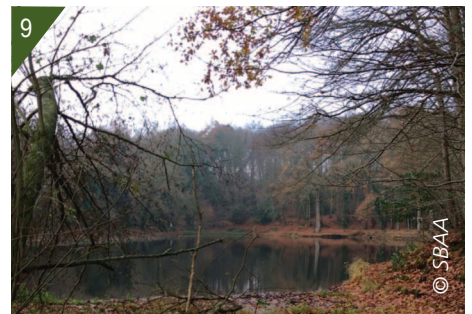
9. The pond four months after the work.
