# New Zealand pigmyweed

## Detection and removal (scraping) of New Zealand pigmyweed in the Acheneau and Tenu marshes (Loire-Atlantique department)

### Sud-Loire Hydraulic Board (SAH Sud-Loire)

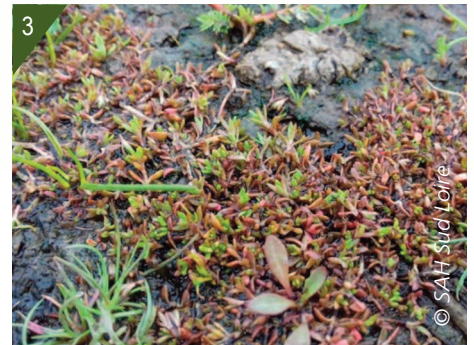
3. New Zealand pigmyweed mixed in with native vegetation.

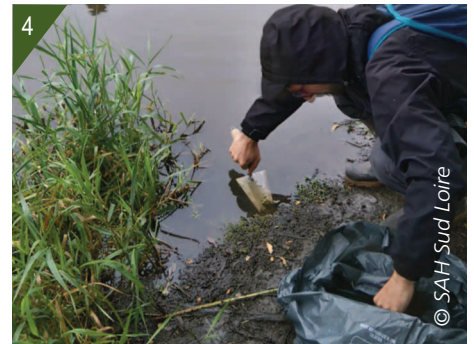
4. Scraping spots colonised by NZP on the banks of the Tenu River.

- The banks of the Tenu River were inspected by boat. Small NZP sites were detected using binoculars and directly eliminated using trowels and shovels to remove the substratum in order to avoid fragmentation of the fragile plants (the roots do not go deep).

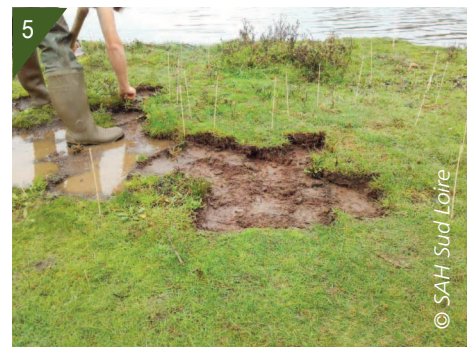
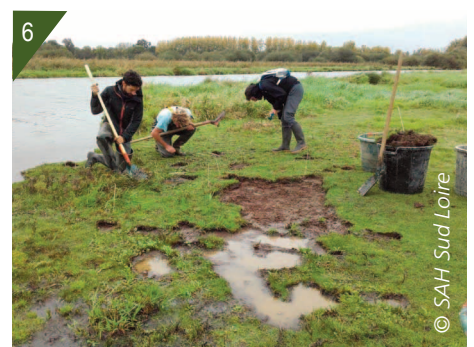
5, 6. Identification of the colonised area and removal of the root system.

- The waste was transported in large recipients and rolled into an agricultural tarp, in a dry area. Particular care was taken during travel to and from sites by personnel to avoid any dispersal caused by trampling on the plants and transporting segments under boots. When landing, the CBNB systematically marked out the colonised area before the uprooting work was started.

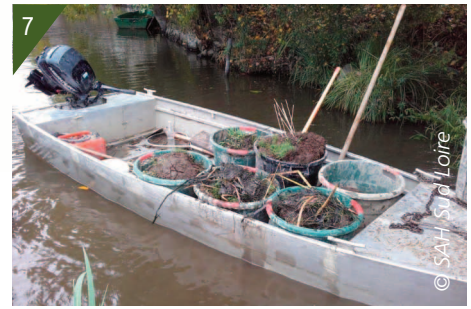
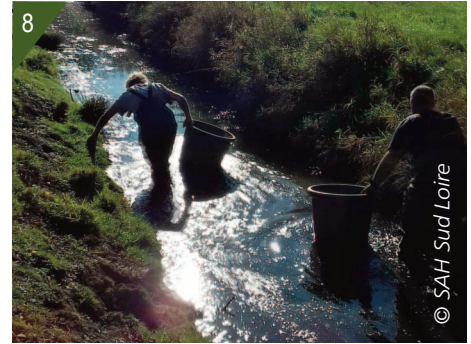
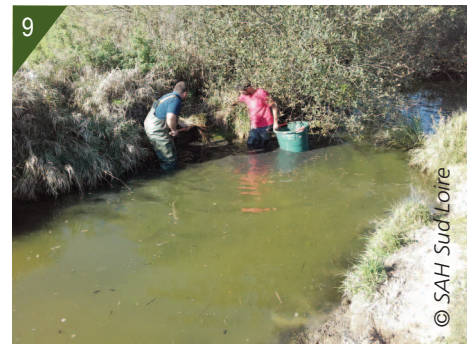
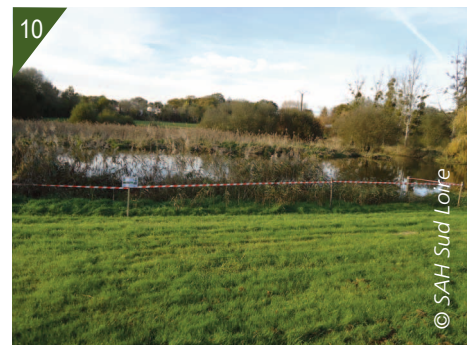
- 7. Transport and elimination of the waste.
- 8. Second intervention in the moat.
- 9. Third intervention in the moat.
- 10. Prohibited area in the port of Saint-Mars-de-Coutais.

- the two banks were first inspected on foot and the NZP sites were marked with paint, then all the marked areas were scraped manually;
- the workers entered the water to collect any floating cuttings and eliminate any plants not visible from the bank (overhangs);
- an initial inspection run was undertaken to check the work and remove any plants that had been missed;
- finally, after letting the sediment settle, a second inspection run was carried out.

■ The harvested NZP was transported using a tractor made available by the town.  
 ■ Even though great care was taken in uprooting and transporting the plants, some NZP may still remain in the treated areas. To avoid any risk of propagation, two areas were fenced off to avoid passage that could disperse the plants. The first was a break in the river bank, approximately ten metres long, in a pasture. It was used by cows to access the river to drink. Informed by SAH, the farmer accepted to fence off the zone. The second was located on the right bank in the port of Saint-Mars-de-Coutais, where access to approximately 50 metres of the bank, used by anglers, was prohibited by prefectural order.

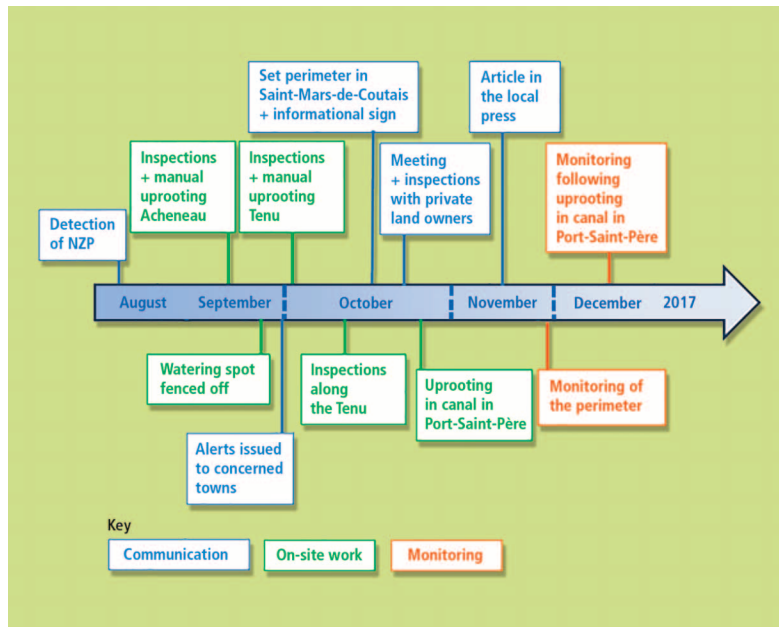
Chronology of the interventions.

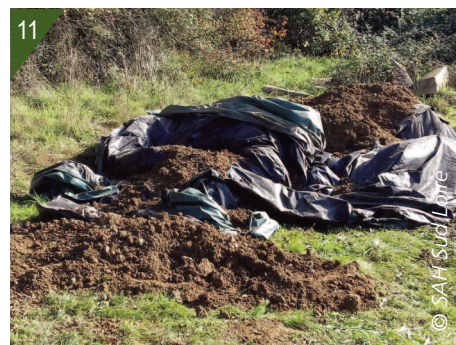
11. Depot for green waste, protected by a tarp.

■ The green waste was transported and stored under a tarp in a town depot, far from any circulation of people or vehicles. The soil removed during uprooting of the plants was placed in a tarp that was sealed to avoid contact with the air and the underlying ground. The contents of the tarp will be monitored to detect any regrowth of the plants and to determine their resistance to confinement (dryness and obscurity).
