New Zealand pigmyweed (*Crassula helmsii*)

Managing colonisation of a town pond by New Zealand pigmyweed in Luré (Loire department)

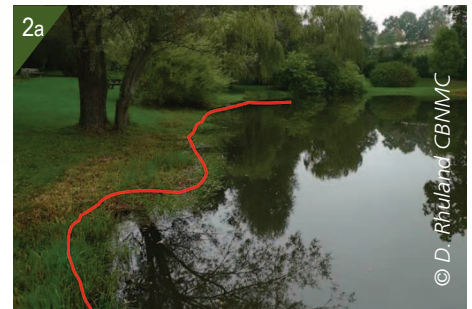
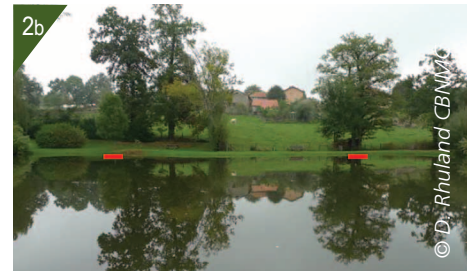
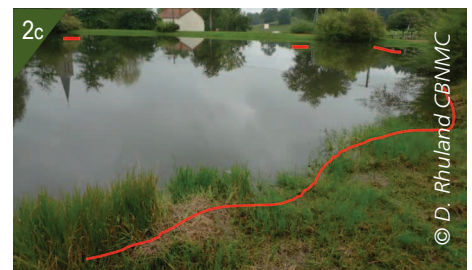
2a, b and c. Red lines showing the position of the pigmyweed in the pond on 2014. 3a and b. Filters installed in the ditch (a) and the wash house (b).

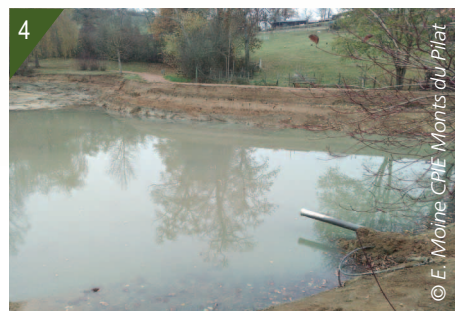
4. The pond during emptying.
5. Removal of the fish from the pond.
6a and b. Dredging.

- To avoid clogging the filters and maintain their filtering capacity, the discharge rate during emptying was kept to a low level. The fish in the pond were caught with nets and taken to the local rendering service. Boots and fishing equipment were cleaned after use.

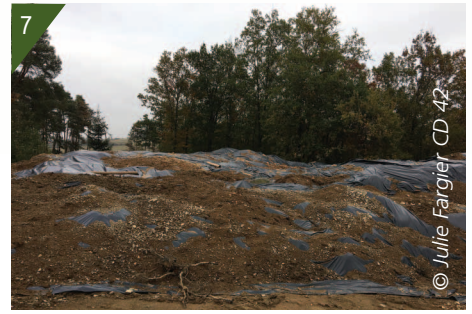
7. Mound of extracted soil.

■ A total of 1 000 cubic metres of soil potentially containing fragments of pigmyweed were removed. The entire area colonised by the pigmyweed was cleaned.

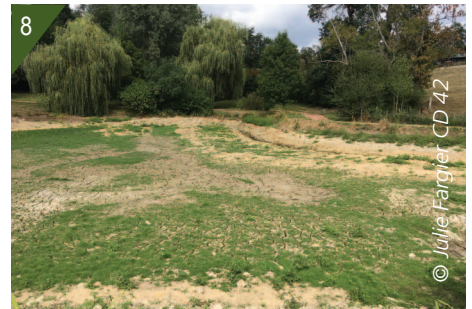
8. The emptied pond.

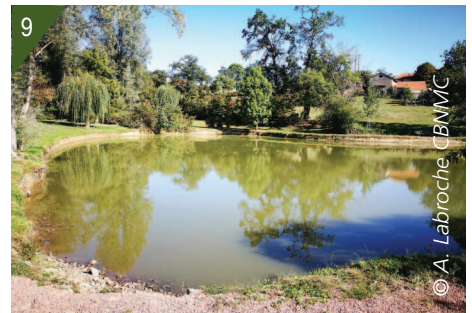
9. The pond after the work.

■ A relatively low water level was observed over the first year of monitoring. The steep banks of the pond (a drop of approximately 60 centimetres) hinder the rapid recolonisation of vegetation. The grass and moss storeys cover 5 to 10% of surfaces in spots. Some flatter areas have formed at the bottom of the banks due to erosion (small landslides). It would appear that colonisation by the pigmyweed cannot proceed top-down because the conducive substrate was removed wherever the pigmyweed was present. The swards around the pond are not favourable for pigmyweed because the substrate is too dry and the vegetation is too dense.
