Water primrose (*Ludwigia* spp.)

Uprooting work on water primrose in the port of Biganos (Gironde department)

Arcachon Bay Board (SIBA)

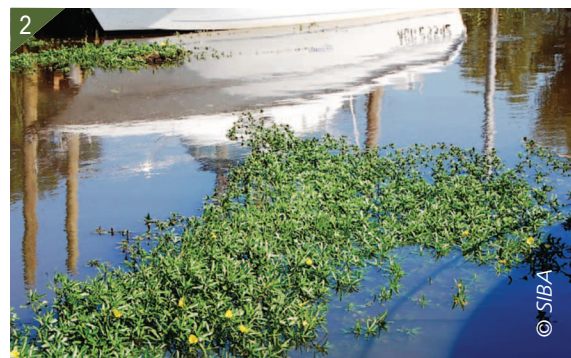
- The water primrose hindered the free travel and manoeuvring of the boats.
- Due to the considerable production of biomass, the plants contributed to the silting of the port. They also modified the level of dissolved oxygen in the water and blocked the movement of aquatic fauna.

1. Map showing the site.
2. A bed of primrose in the port of Biganos.

- After reviewing the management reports for water primrose collected by the National Work Group on Biological Invasions in Aquatic Environments (IBMA¹), CBNSA made a number of recommendations:
 - identify and characterise the invaded areas, detect the possible sources of plants and cuttings;
 - uproot the beds (manually or mechanically) while taking care to avoid the dispersal of the plants downstream by setting up fine nets around the beds;
 - establish monitoring procedures and undertake any necessary uprooting work in subsequent years.
- Given the small surface areas requiring work and the technical constraints (earthen banks and a bridge to the central section incapable of supporting heavy machinery), the decision was made in favour of manual uprooting rather than the mechanical uprooting.

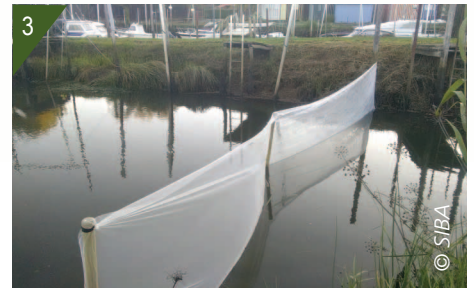
3. The net intended to prevent dispersal.
 4, 5. Manual uprooting of water primrose in the central section.
 6. The backhoe loader operating from the bank.
 7, 8. A bed of water primrose at low tide (7) and following the work (8).

- A net (mosquito netting) was placed at the entry of the central section. It spanned the entire width of the section (ten metres) and also blocked off a bed of water primrose detected near the entry. Two small boats were positioned in the colonised area while the tide was dropping. They served to collect the uprooted plants that were far from the banks. The boats rested on the bottom until the tide came back in and they could be moved for unloading.

- The use of the net to avoid dispersal was not satisfactory because the wind hindered its effectiveness. A system of floats and weights may be more effective and would adapt to the changing water level due to the tides.

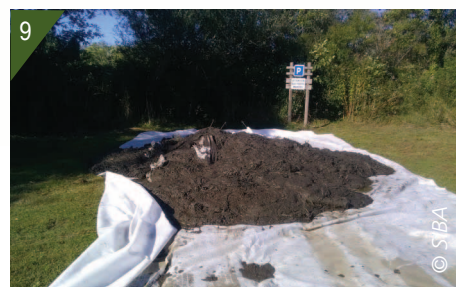
9. Storage and drying area for the uprooted plants.
10, 11, 12. A bed of water primrose at high tide (10), at low tide (11) and following the work (12).

- The unloading zone for the water primrose was located near a parking lot, on land well above the high-tide mark. The uprooted plants were drained of water on the geotextile fabric and then transported to the town technical centre. After drying in a blocked off area of the technical centre, they were transported to composting units with other waste from the town.
