Removal of five lakes on the Val des Choues stream

Category	Restoration
Type of operation	Pond removal or derivation of watercourse
Type of environment	Headwaters
Issues at stake (water, biodiversity, climate)	Good status of habitats, conservation of species of national or european importance and river continuity
Start of operation	June 2006
End of operation	2007
Length of watercourse affected by the works	700 m

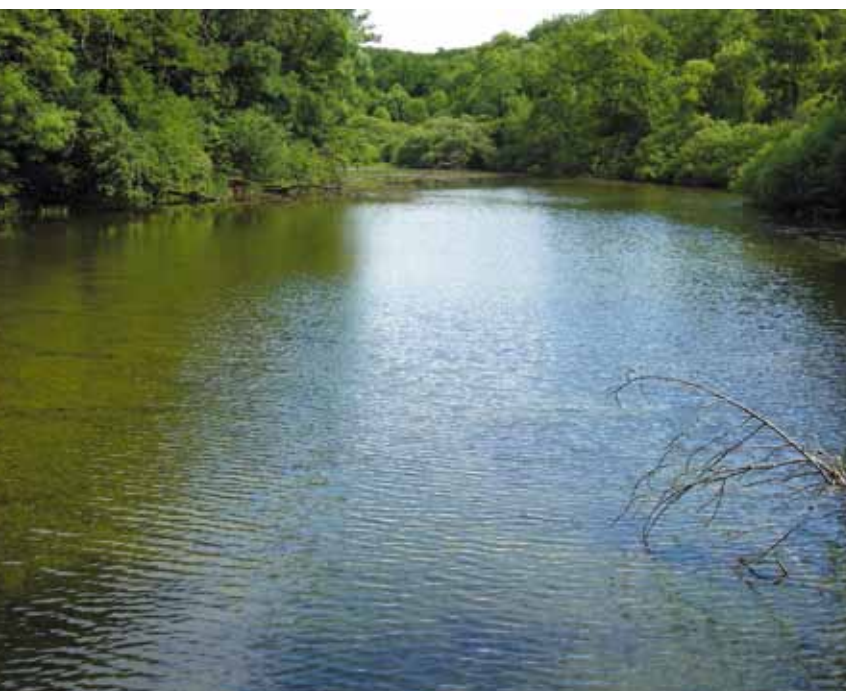
The most upstream pond is retained. It is a site of heritage interest (historic and faunistic).

The most upstream pond could not be removed due to its major heritage value (historic and faunistic). This pond was linked to the other ponds by the watercourse and a parallel canal (created for fish-farming purposes).

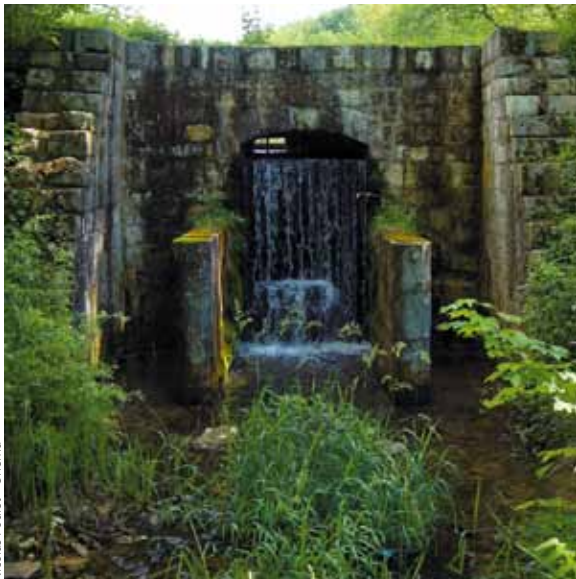
The preserved heritage pond embankment.

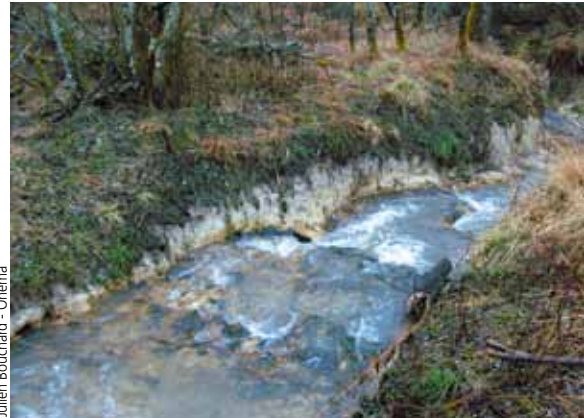
The Val des Choues stream reforming its bed in the sediment left by the ponds (March 2009).

The initial results of the scientific monitoring have been very promising: the winter flow rates have allowed the stream to re-establish its bed throughout almost the entire length of the restored linear watercourse, which is following a slightly sinuous course in a main shallow bank channel (banks only 10 to 20 cm deep). The response is better than expected, with the bed developing very quickly in favour of biogenic habitats related to the presence of woody debris. However, coarse alluvia (small pebbles, gravel and sand) remain scarce and the bottom of the bed remains muddy.

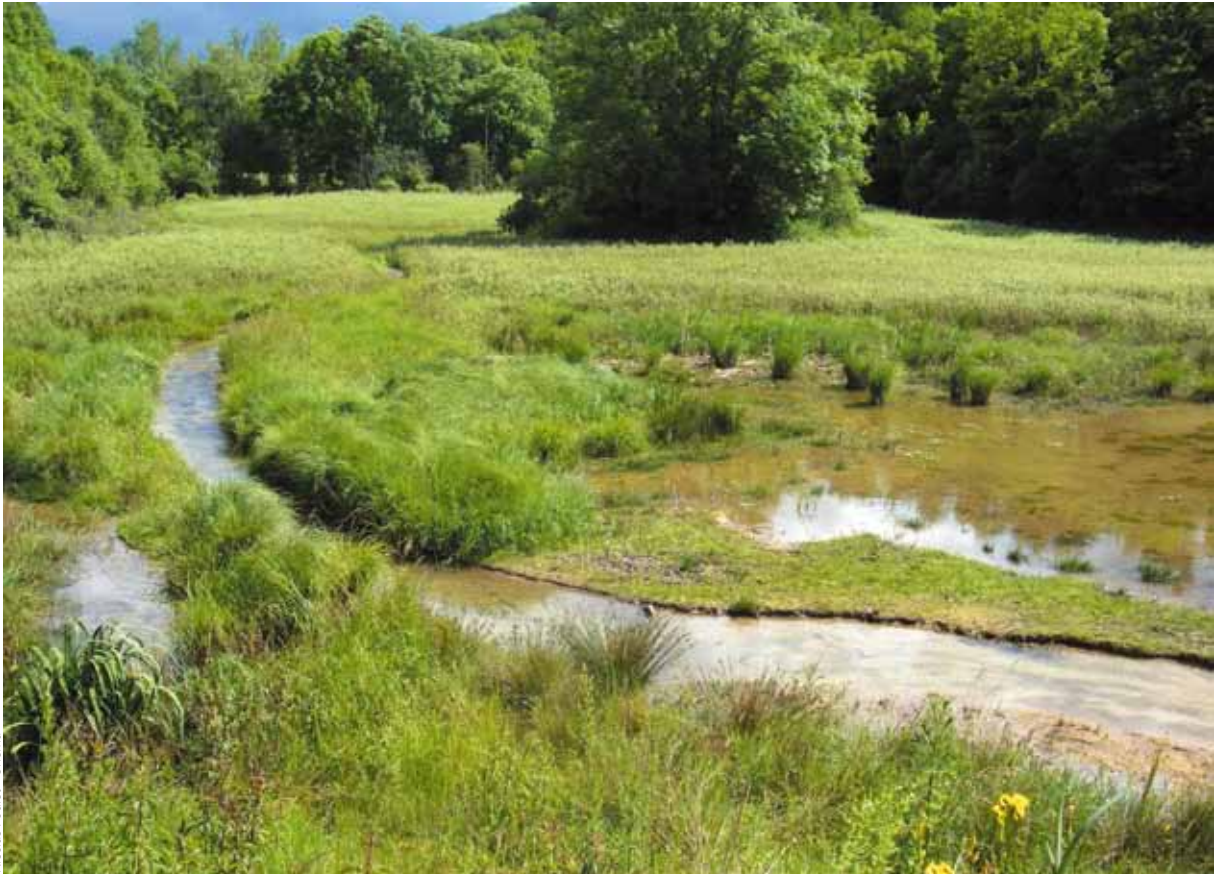
The new sinuous course of the stream in June 2009.

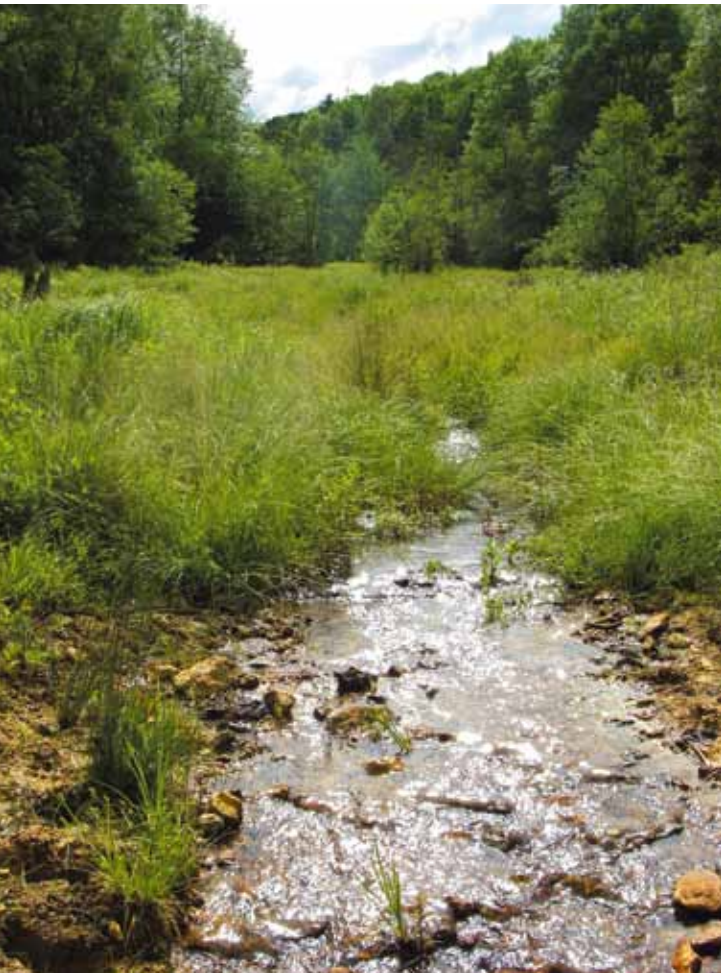
The Val des Choues stream within the impoundment area of the former ponds. Detail of particle size in the watercourse in June 2009
