Removal of the Cussy weir on the Maria Stream

The operation

Category	Restoration
Type of operation	Partial or total weir/dam removal
Type of environment	Headwater stream
Issues at stake (water, biodiversity, climate)	River continuity

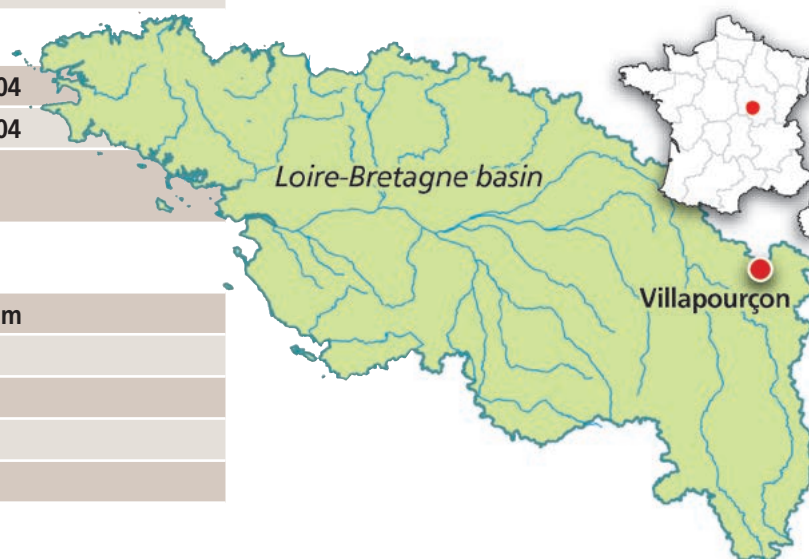
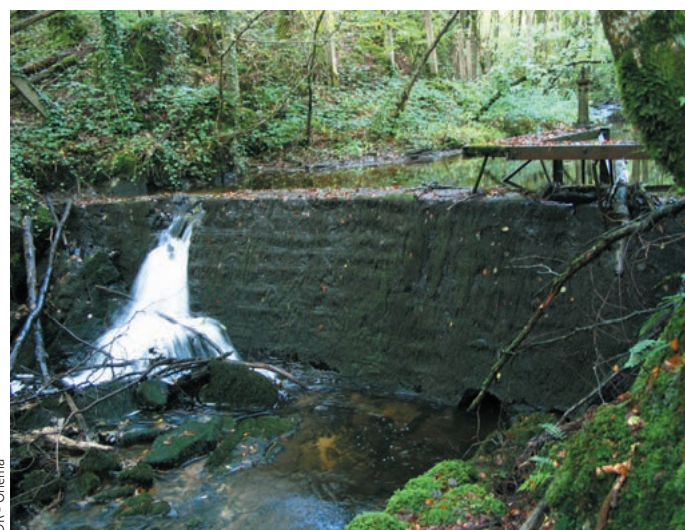
The Cussy weir.

The weir had a major impact on the environment in that it completely blocked the upstream migration of trout and made difficult the downstream migration of juveniles. In addition, it blocked the transfer downstream of sand, gravel and stones.

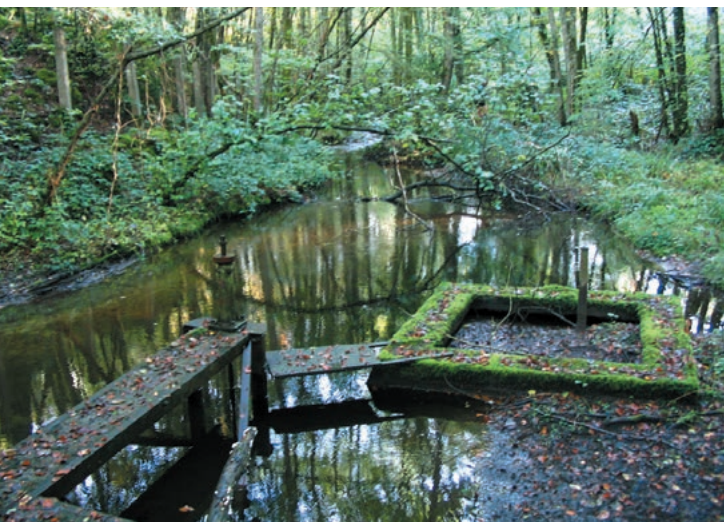
The impounded reach upstream of the weir.

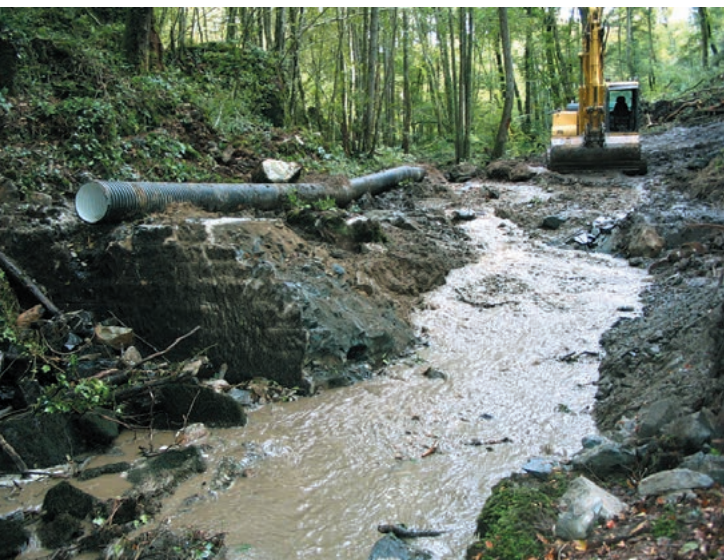
The stream in October 2004, toward the end of the project.

During the project, the water was diverted through a pipe. A straw filter was positioned downstream of the weir to trap any fine sediment. To start, the sediment deposited upstream of the weir was removed. It was spread over the banks, however the larger elements were left along the stream in order to be picked up later by it. The weir was then destroyed and the banks were stabilised using large rocks from the levee for the weir and from the surrounding area.

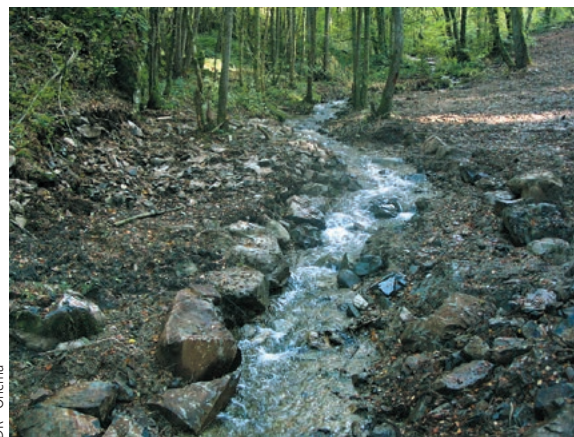
The stream in October 2004, a short distance upstream of the former weir. The banks are stabilised by large rocks drawn from the weir embankment.

ly recolonised the area and stabilised the banks. The large rocks positioned along the foot of the banks have prevented lateral erosion. Further upstream, regressive erosion has created a series of small steps that do not constitute obstacles for fish and contribute to habitat diversity.

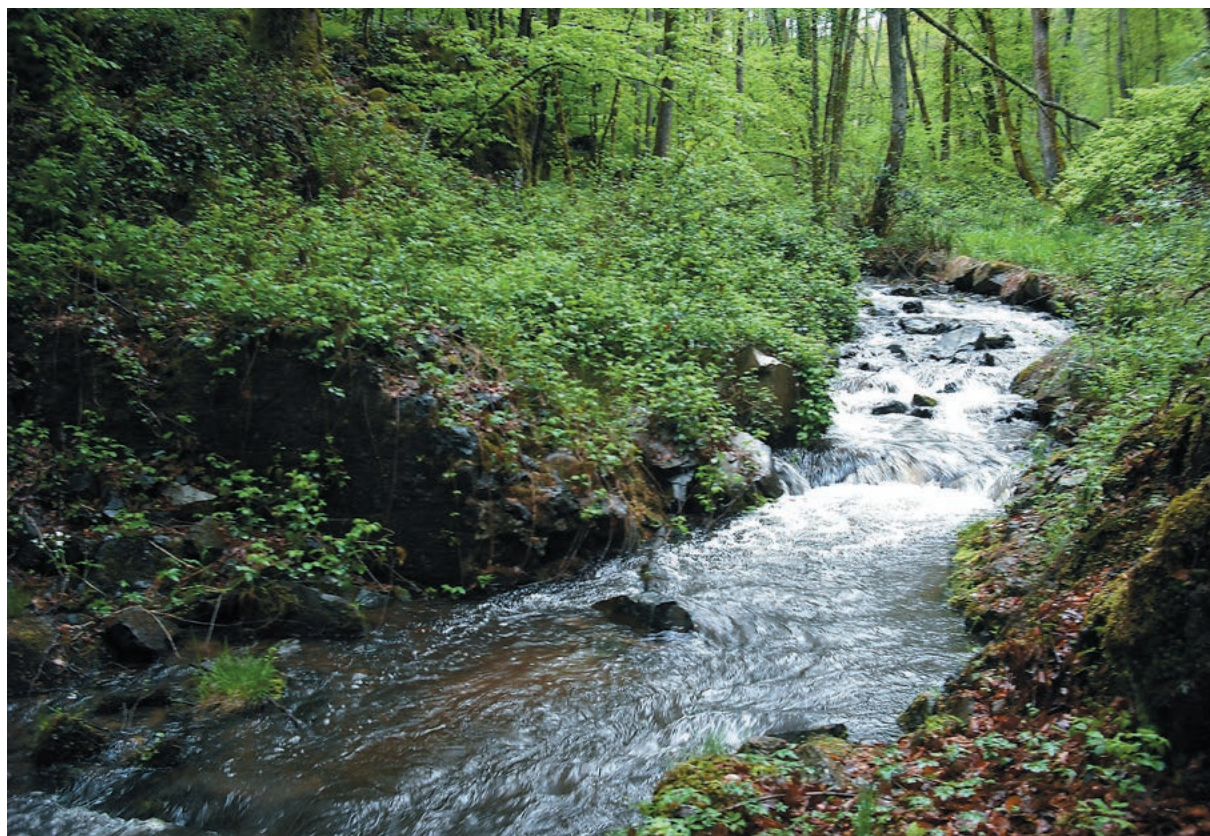
The stream in 2009, five years after being restored.

The removal of the weir has restored sediment transport. Significant inputs of gravel have been observed downstream, thus recreating a favourable habitat for trout reproduction. The vegetation has natural-
