Removal of the Brosse weir on the Soanan River

Category	Restoration
Type of operation	Partial or total weir/dam removal
Type of environment	Intermediate river zone
Issues at stake (water, biodiversity, climate)	River continuity

Start of operation	September 2010
End of operation	September 2010
Length of river affected by the works	300 m

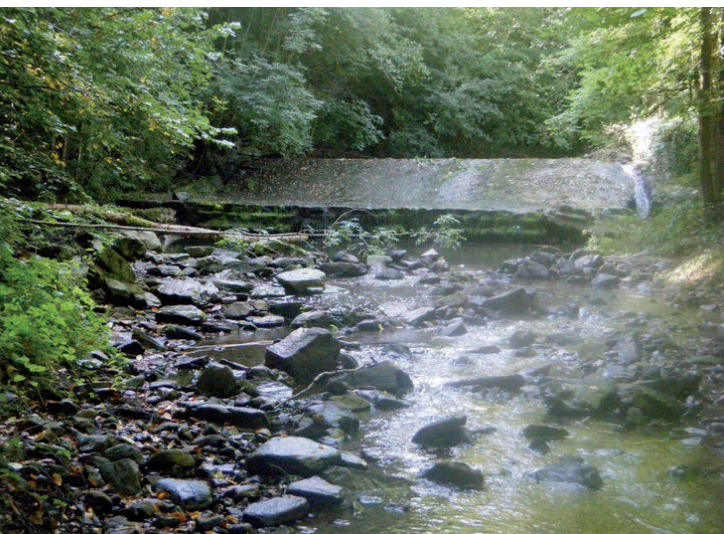
The Brosse weir, standing at 2.2 metres tall, was an old hydraulic structure previously used to irrigate nearby crops and meadows, via a leat. However, the structure had served no purpose for many years. But the weir still existed and continued to impact the aquatic environment.

The Brosse weir prior to its removal. August 2010.

The impoundment behind the weir had become completely cut down and the bed surface was clogged with fine sediment. Paving had taken place on the downstream bed and the remaining grain sizes were too coarse to be transported, thus leading to a deficit in the distribution of sediment sizes.

The Brosses weir was completely destroyed and the rubble was removed, except for a few large rocks left in the bed, where the weir once stood. During the works, the river was temporarily diverted to avoid the fine sediment being washed away. The dissipation pool of the weir served as a sedimentation pool. A rescue fishing campaign was undertaken prior to the works to limit the impact on the fish population.

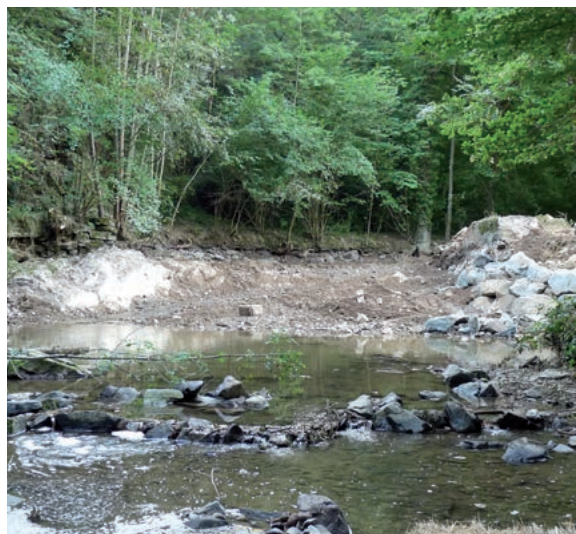
The site after the removal of the weir. September 2010.

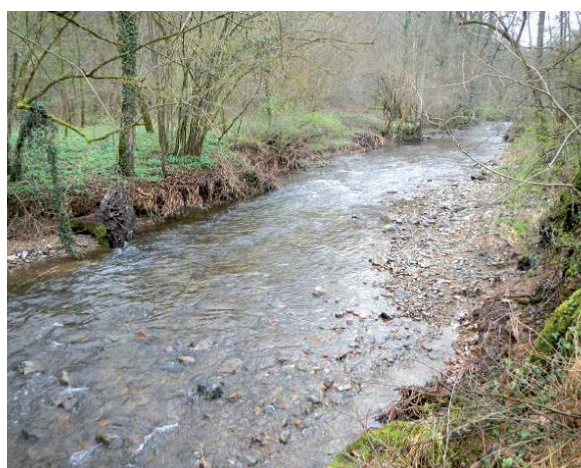
In 2017, following numerous floods including a particularly morphogeneous flood in 2016, it was decided to pursue monitoring on the Soanan. The flood in question reduced some of the irregularities in the long and cross profiles of the river. The slope is now similar to the steady slope observed in the rest of the river. However, regressive erosion upstream of the former weir has been observed.

Analysis of the monitoring data revealed reactivation of sediment over a distance of 120 metres upstream of the former weir and, downstream, sediment progression to the confluence with the Azergues River.

The Soanan upstream of the former weir following the ten-year flood of 2016.

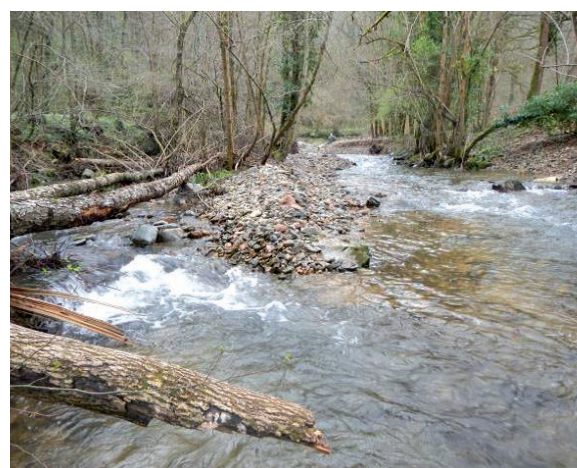
View of the gravel shoal created in the middle section of the river by the 2016 flood, downstream of the former weir.
