Removal of the dam on the Allier River at Saint-Étienne-du-Vigan

The operation

Category	Restoration
Type of operation	Partial or total weir/dam removal
Type of environment	Headwater stream
Issues at stake (water, biodiversity, climate)	River continuity, good status of habitats

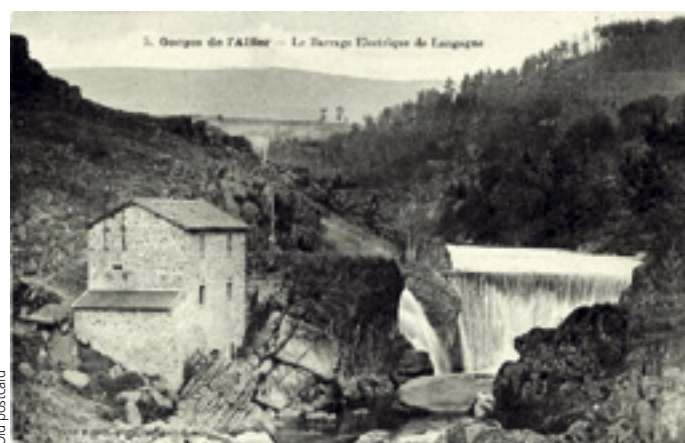
The dam in the early 1900s.

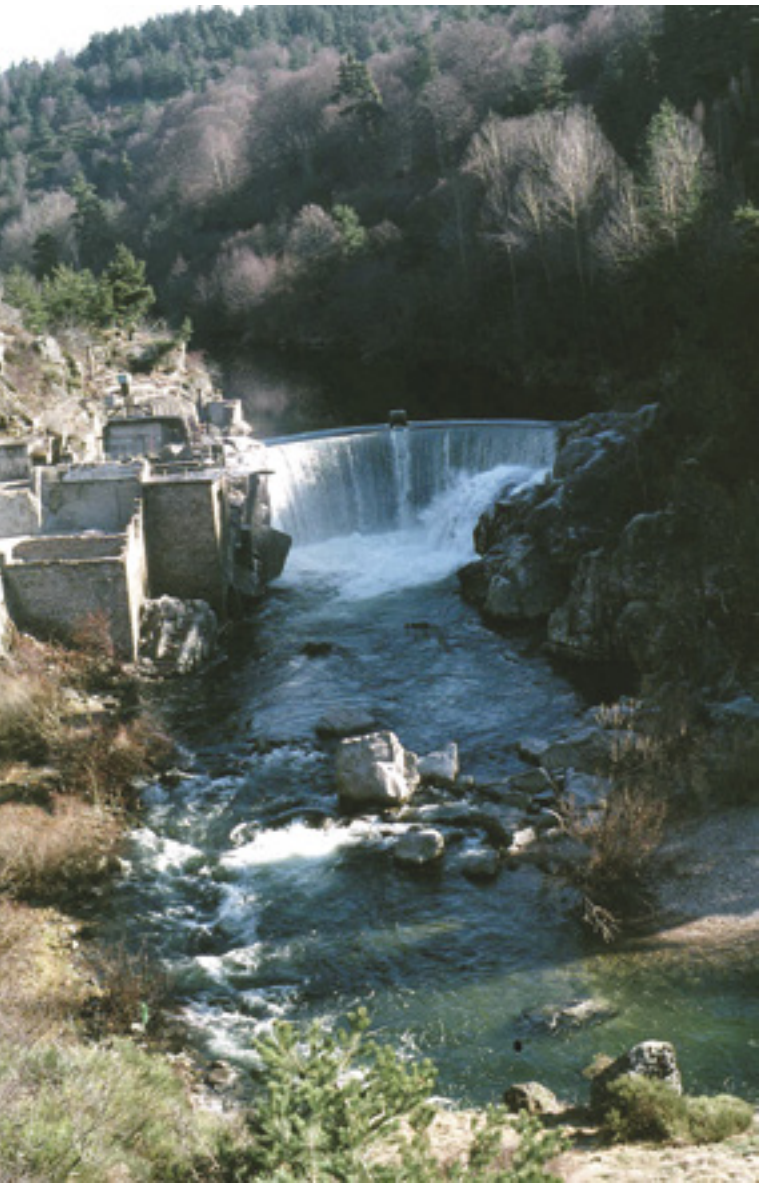
The Saint-Étienne-du-Vigan dam in 1996, following the demolition of the power station.

The work consisted of totally removing the dam and the power station. It took place in three phases:

- November 1996, demolition of the power station;
- January 1997, an additional gate was installed to empty the reservoir. Emptying of the reservoir took place in November 1997 during the high-water period in order to dilute the sediment at the bottom of the reservoir;
- spring 1998, the riverbed was bypassed to enable work under dry conditions, then on 24 June 1998, the dam was blown up because the layout of the site precluded the use of heavy machinery. The site was then restored to its original condition.

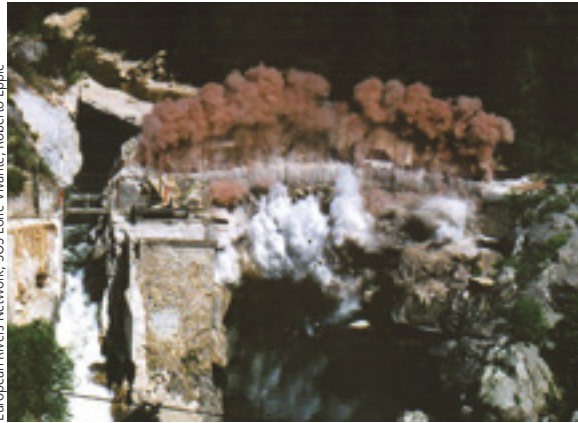
The demolition of the Saint-Étienne-du-Vigan dam in June 1998, using dynamite. The river water was rerouted along the right bank.

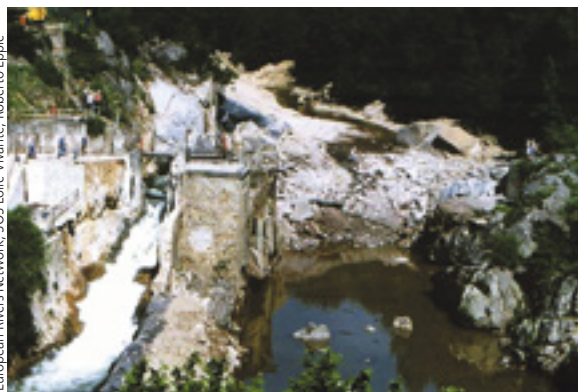
The site following demolition of the dam in 1998.

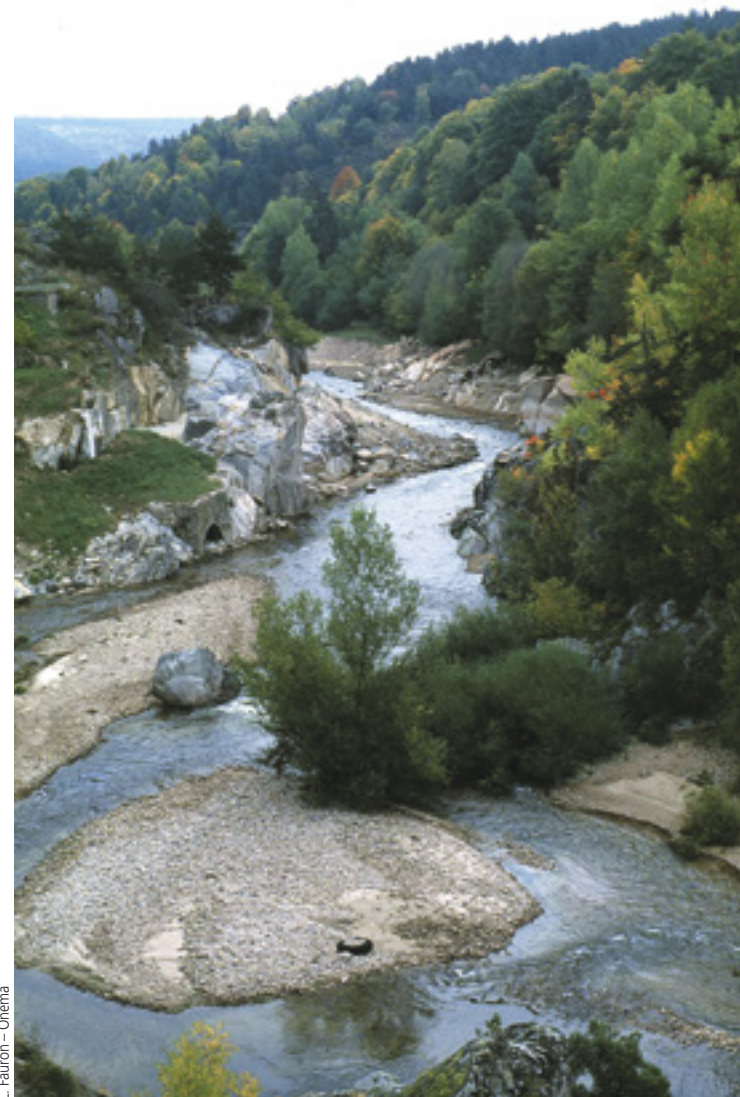
The site of the Saint-Étienne-du-Vigan dam in October 1998, following the restoration work.

In terms of its morphology, the river is in the process of rapidly achieving a new balance. Sediment transport has restarted and now supplies the downstream spawning grounds with gravel.
