# Parrot-feather watermilfoil

## Managing parrot-feather watermilfoil in the Riondaz pond in Viriat (Ain department)

### The Reyssouze river-basin board (SBVR)

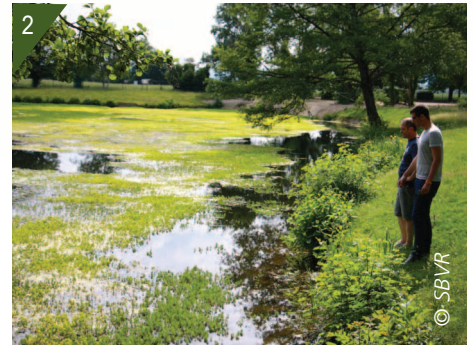
2. The pond colonised by parrot-feather watermilfoil.

- Over the two-year period, the PFW developed considerably in the pond. In 2017, it had covered the entire surface area of the pond and replaced the previous beds of aquatic plants.

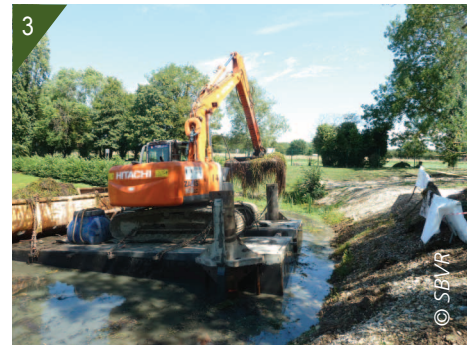
3. Mechanical uprooting by the excavator on a barge.

- SBVR decided to launch a project to manage the PFW in order to avoid any risk of species dispersal to other sites in the river basin and to restore the recreational activities desired by the pond owner.
- The work consisted of uprooting the PFW using an excavator loaded onto a barge that enabled it to access the entire surface area of the pond. The excavator was equipped with a special bucket with "claws" designed to gather a maximum amount of plants while leaving the fine and coarse sediment.

■ The work took place over seven days in August, including five days of uprooting.

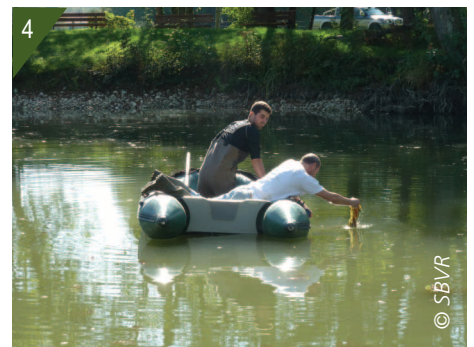
4. Follow-up manual uprooting from a boat.

■ In September and October, two sessions of manual uprooting from a boat were organised to reduce the quantity of new growth.

- Manual uprooting from a boat is not an easy task. The boats were difficult to manoeuvre and the wet plants are very heavy, two conditions that hindered movements about the pond. The participants rapidly showed signs of fatigue.

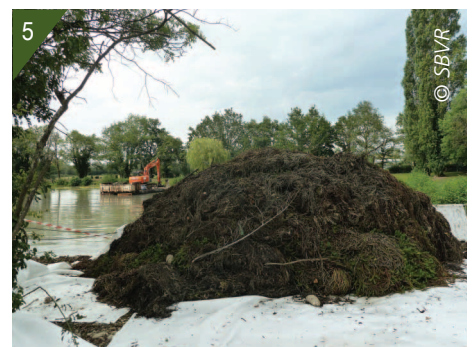
5. Green waste produced by the mechanical uprooting in 2017.

■ The green waste was stored on a site where there was no danger of flooding. The waste was placed on a geotextile fabric to avoid contact with the soil. The PFW drained and dried *in situ* over a period of several weeks before being transported to a special centre for burial.

■ The mechanical uprooting in 2017 covered almost the entire pond and approximately 40 metric tons of drained plants were later transported from the site. A small island was removed manually because the low water level during the summer hindered the access of the barge.
