Removal of the Kernansquillec dam over the River Léguer

The operation

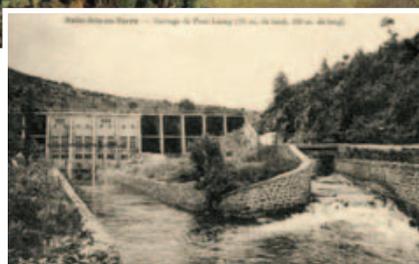
Kernansquillec dam and its reservoir in the last century

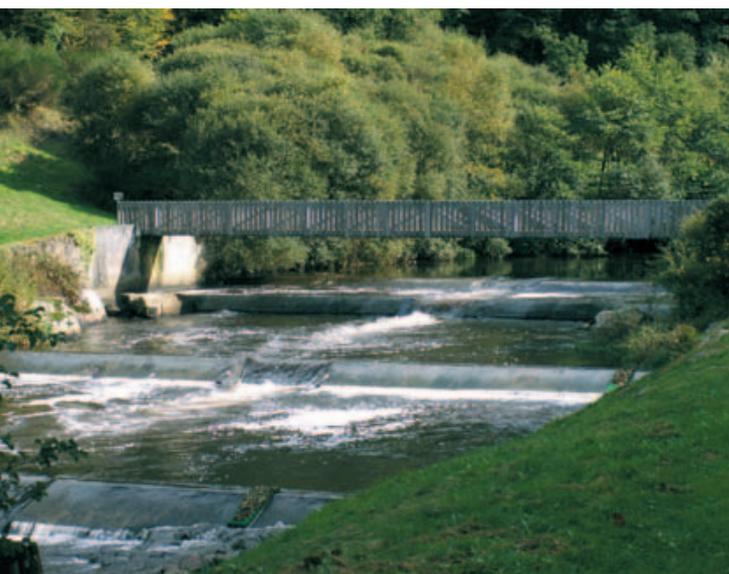
Site of the former dam in October 2009: footbridge and successive weirs.

established its bed and three 50-centimetre weirs were constructed in order to retain any sediments that might have escaped the suction dredging and reduce the risks of regressive erosion. Before the floodgates were opened, the fish were transferred upstream of the dam in order to reduce the risks of mortality due to an excessive influx of sediments. The dam was then demolished. Only a single arch was preserved as a heritage symbol of the prosperity of a bygone era.

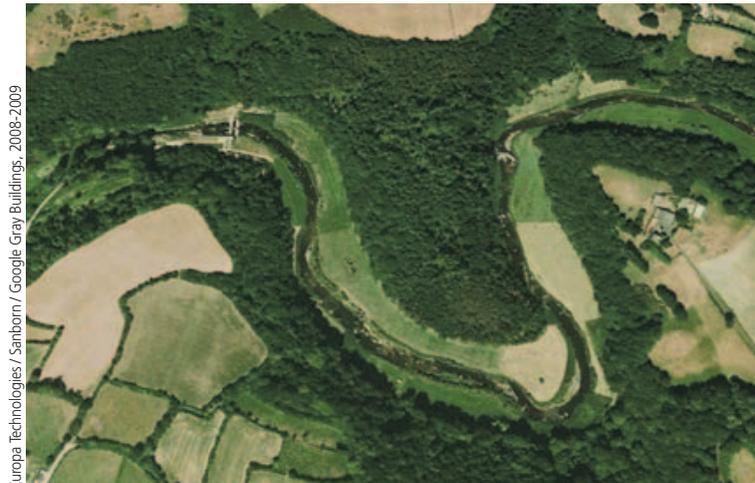
The Léguer valley after the removal of the Kernansquillec dam.

Overall, the visible but unquantified results of the different elements (water quality, ecological condition, etc.) are very satisfactory. The site has been rehabilitated in the least intrusive manner possible. Five years after the drainage of the reservoir, the banks had stabilised and the river had re-established its meanders, while its flow and gradient had evened out. Alternating

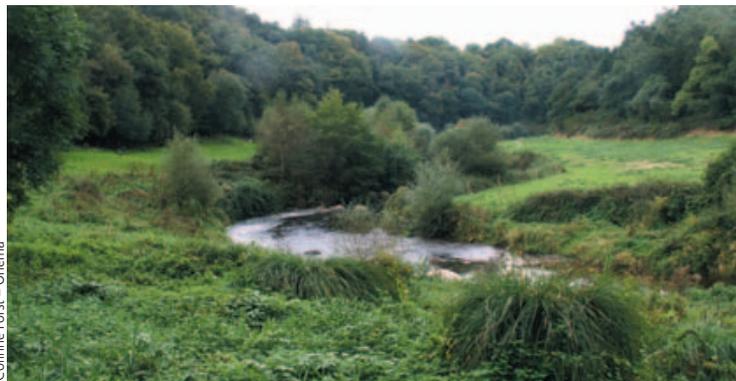
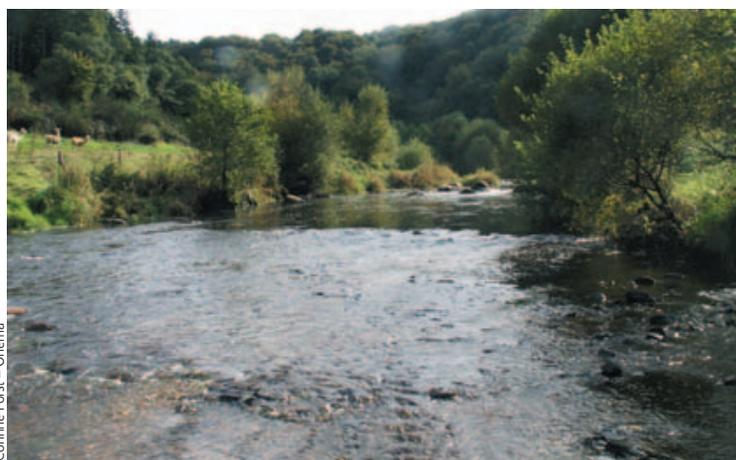
The Léguer within the former reservoir area in October 2009: variations in the stream flow and particle size distribution.

riffles and glides have appeared. The typical bankside vegetation found locally in the area has recolonised the entire site. Successive winter floodwaters have improved the substrate characteristics, creating a heterogeneous particle size distribution that is favourable for fish spawning.
