→ Removal of the Maisons-Rouges dam over the River Vienne

The operation

Category	Restoration
Type of operation	Total or partial dam or weir removal
Type of environment concerned	Lowland river
Issues at stake (water, biodiversity, climate)	River continuity
Start of operation	June 1998
End of operation	April 1999
Length of river affected by the works	15 km

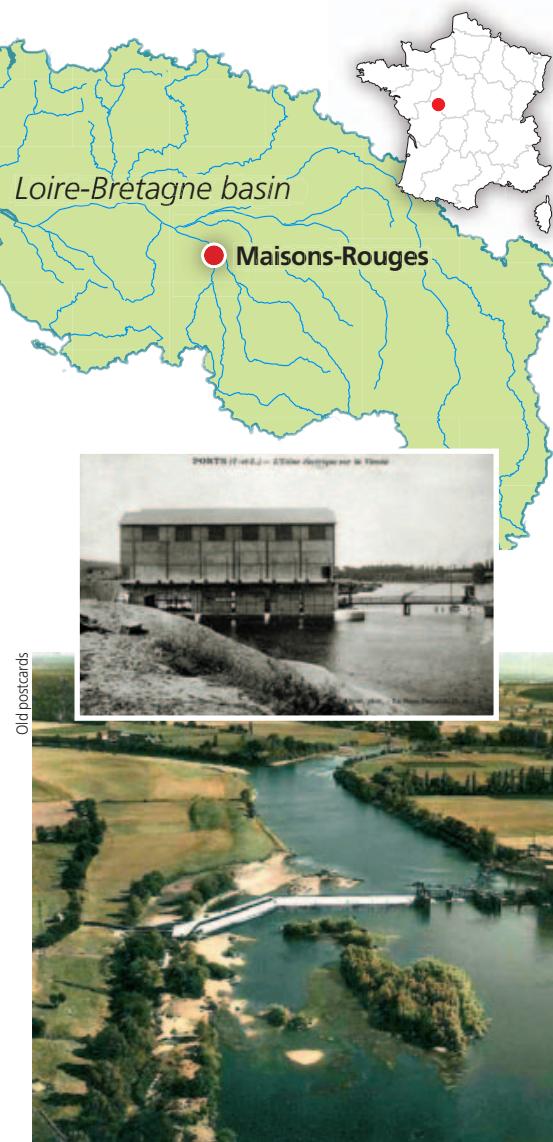
Maisons Rouges dam before the removal

At the start of the 1920s, Maisons-Montrouge dam was built to a height of 3.8 metres over the Vienne in order to meet the power requirements of the paper mills at La Haye Descartes.

This dam, built 250 metres downstream of the confluence with the Creuse, created a blockage in both of these basins. The virtually stagnant impoundment caused by the dam was estimated to cover 15 km in total: 8 km on the Creuse and 7 km on the Vienne.

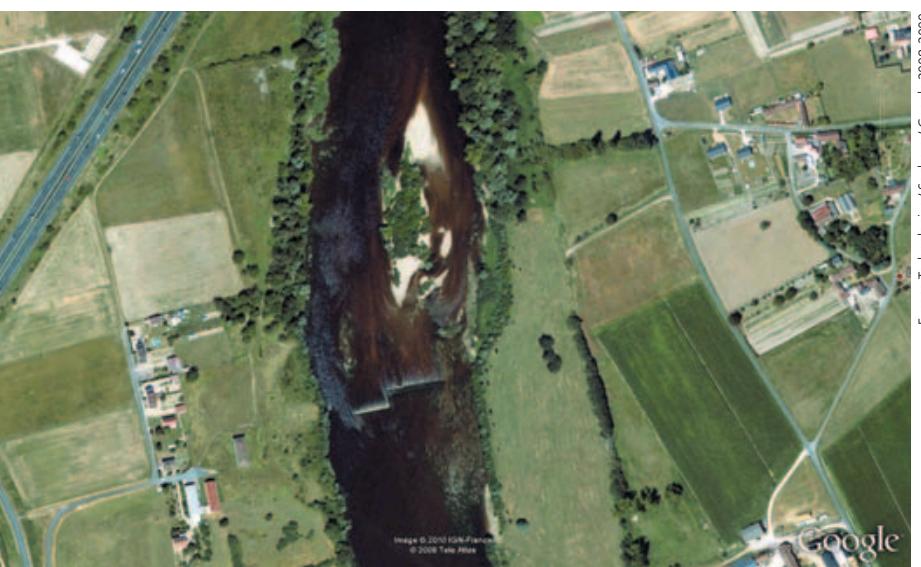
Satellite photo of the former site of the Maisons-Rouges dam. Alluvial banks have appeared and vegetation has grown on the banks.

The habitats of the low-water channel of the Creuse and Vienne, situated in the former impoundment area, have diversified. In 1988, the bottom of the impoundment bed was mainly covered with sands, whereas riffles have now appeared, incorporating coarser materials. Ten riffles have now re-emerged, six on the Creuse and four on the Vienne. Likewise, small islands, mainly consisting of gravel, have emerged. The substrate-velocity characteristics have become more heterogeneous, offering numerous biogenic environments for invertebrates and fish.

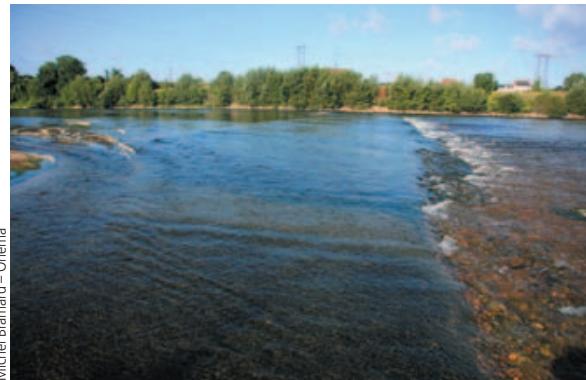
Persistent weir on the site of the Maisons-Rouge dam in July 2008.

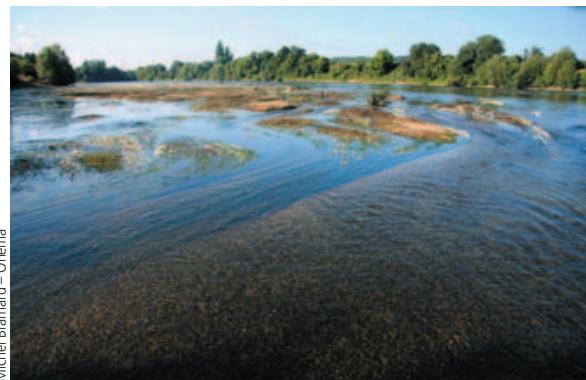
The former impoundment of the Maisons-Rouges dam in July 2008 – nine years after its removal.

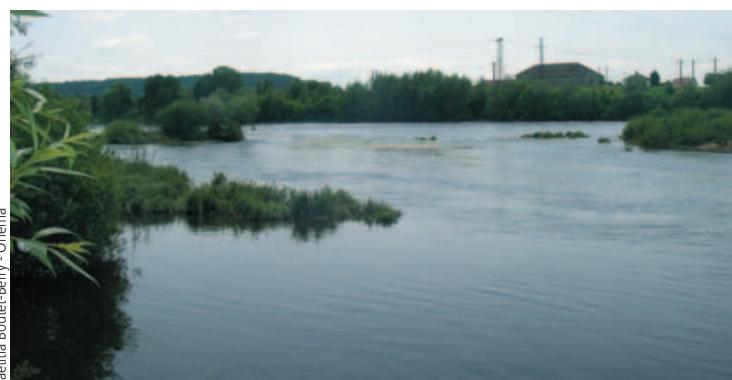
The Maisons-Rouges site in 2009 – ten years after its removal.

With regard to flora, a significant development of the shrub layers and tree strata has been observed on the river banks of the Vienne and Creuse, and also on the alluvial banks within the area of the former dam. In 2009, an analysis of landscape changes revealed that a visitor discovering the landscape of the old dam would find it hard to imagine the previous layout of the site.
