# Flood mitigation and restoration of continuity in the Mérantaise River in Gif-sur-Yvette

Category	Restoration
Type of operation	Partial or total weir/dam removal, meandering, bypassing/removal of a pond, return to the original bed
Issues at stake	River continuity
Start of operation	June 2013
End of operation	July 2015
Length of river affected by the works	1200 metres

Name	Mérantaise River, tributary of Yvette river in Essone
Mean gradient	8,5‰
Mean discharge	0.09 <sup>3</sup> /s

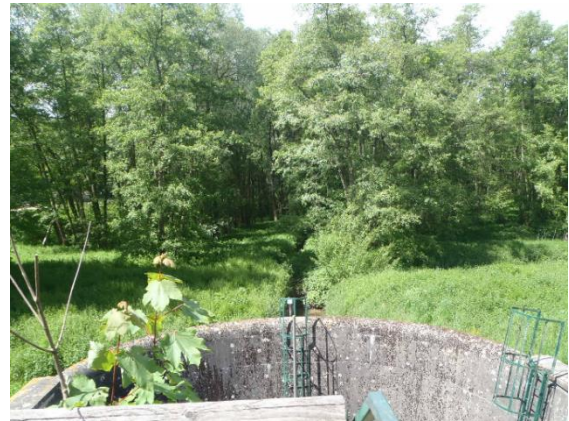
Figure 2: The spillway and discharge-regulation system and the concrete channel prior to the works

The installations at the output of the flood-control basin (spillway, discharge-regulation system) were renovated and modified to improve the hydraulic

functioning of the installations and to restore river and sediment continuity at that point in the river.

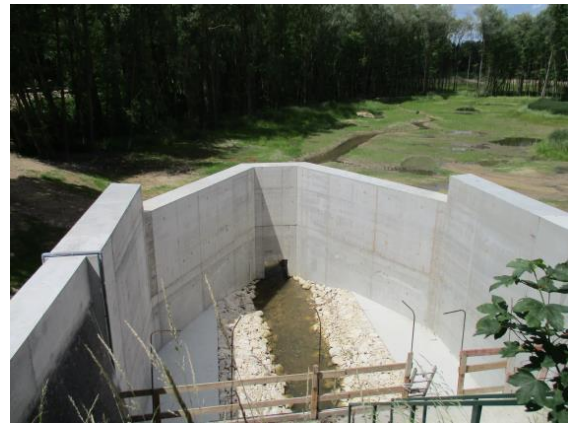
Figure 3: The spillway and discharge-regulation system and the new bed of the Mérintaise after the works

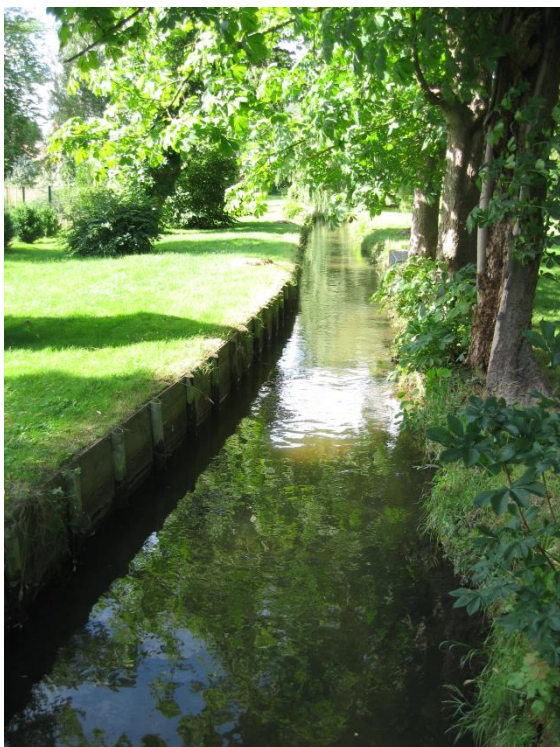
Figure 5: Gibeciaux mill prior to the works

Downstream of the structure under the Avenue du Général Leclerc, where the Gibeciaux mill is located, meanders were created over a section 76 metres long and the banks were stabilised using bio-engineering techniques.

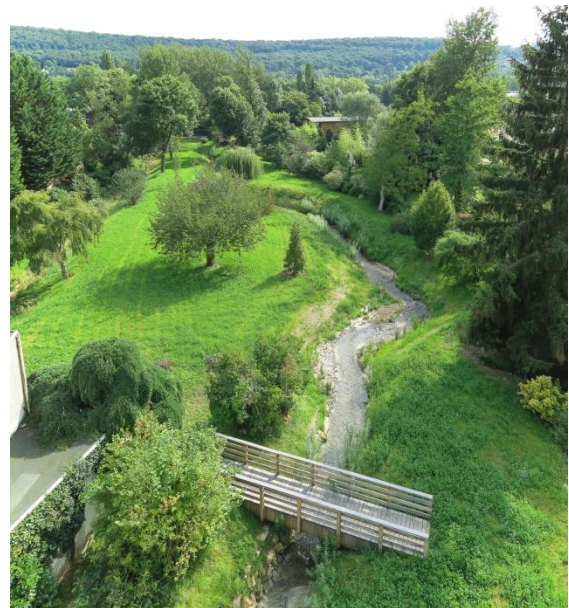
Figure 4: Aerial view of the “Gibeciaux” mill after restoration works

In the park next to the Gibeciaux mill, downstream of the buildings, meanders were created and the reach was stabilised with two “rock ramps”. This formerly raised section is now aligned with the long profile of the river.

The structures for the wash house were “deconstructed” and rebuilt taking into account the new cross and vertical profiles of the Mérantaise.
