Removal of riverbank protection or river embankments

Reactivating river dynamics in the Vieux-Rhône River (non-navigable section) at Cornas, Roubion and Petite Île

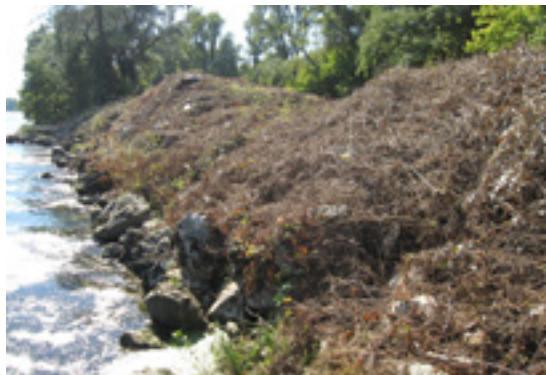
Old Girardon dike along the Rhône where flood debris accumulated, before the dike was opened. September 2011.

• opening gaps in the longitudinal dikes (stone banking) and removing certain transverse groynes. This was a key step in the procedure. The Girardon structures were significantly modified at certain points by lowering the dikes by 30 to 70% in height over a distance of 20 to 100 metres depending on the gap;

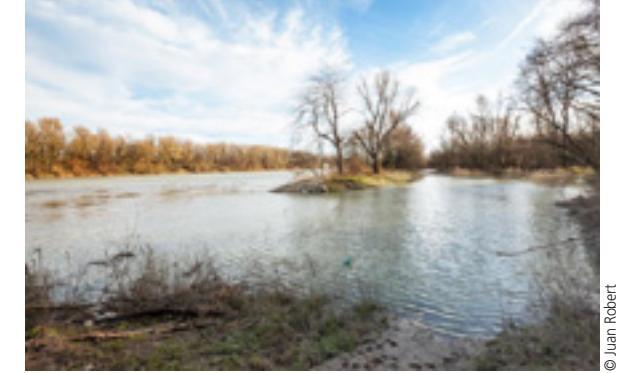
Connection of flood storage zones in Cornas, during flooding. December 2012.

Connection frequencies were modified on the Cornas and Petite Île sites and now occur annually. In the upper section of the Roubion site, connections take place twice per year. Costs

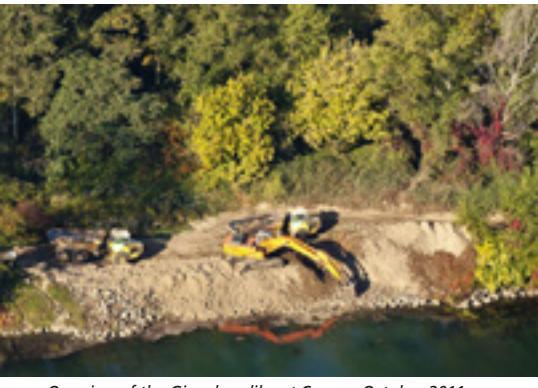
Opening of the Girardon dike at Cornas. October 2011.

• on the Cornas site, 1,600 m³ of stone banking and 5,900 m³ of finer materials (gravel-silt mix);

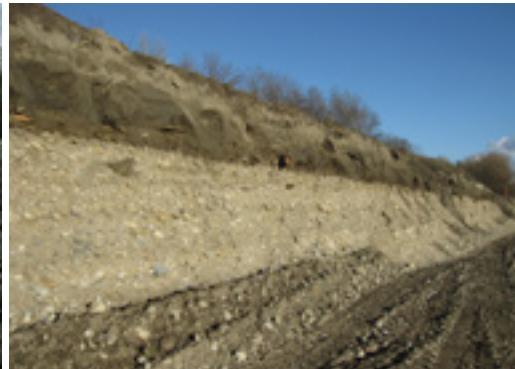
Vertical earthwork on the Petite Île site. The stratification (gravel layers) is clearly visible.

• on the Petite Île site, 1,100 m³ of stone banking and 15,900 m³ of finer material (silt, sand).

- removal of all the finer materials by the river;
- erosion at the base of the vertical banks created,
- collapse of the sloping bank and retreat of the crest.
