Restoring the natural dynamics of the upper Adour

Category	Restoration
Type of operation	Removal of riverbank protection or river embankments
Type of environment	Intermediate river zone
lssues at stake (water, biodiversity, climate)	Good habitat status, control of invasive species
Start of operation	1997
End of operation	2004
Length of river affected by the works	12,100 m

Name	Adour river
Distance from the source (at upstream end of works section)	25 km
Mean width	Single channel: 9 to 15 m Braided channel: 15 to 50 m
Mean gradient	Single channel: 17‰ Braided channel: 10‰
Mean discharge	9.57 m ³ /s

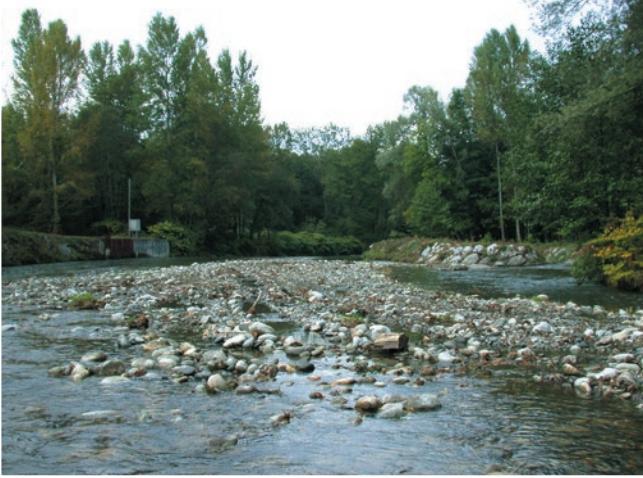
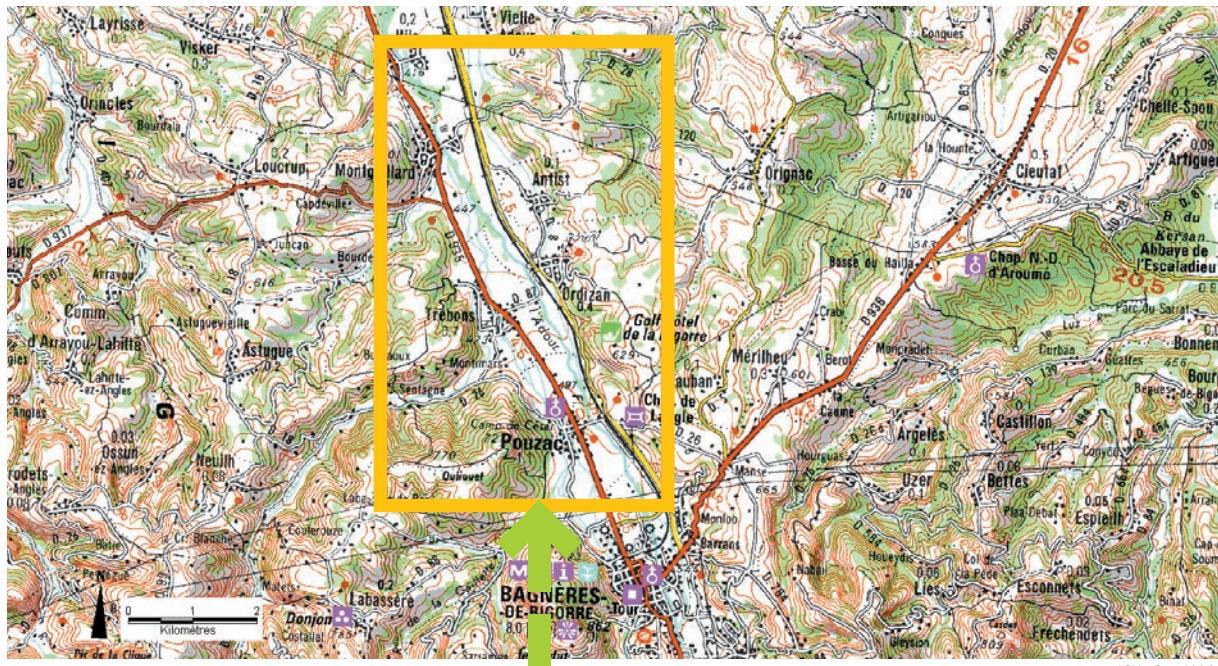
An alluvial bar on the upper Adour before (above) and after (opposite) the works.

The works consisted of removing the bunds by regrading the banks and modifying the management techniques for accumulated debris and dead wood. The side channels that had been cut off were restored and a network of secondary channels was created to manage flooding. Bank-protection systems were installed only as needed and exclusively using bio-engineering or mixed techniques. Sectors with sparse vegetation were planted. Finally, efforts were made to counter the development of Japanese knotweed, an invasive species.

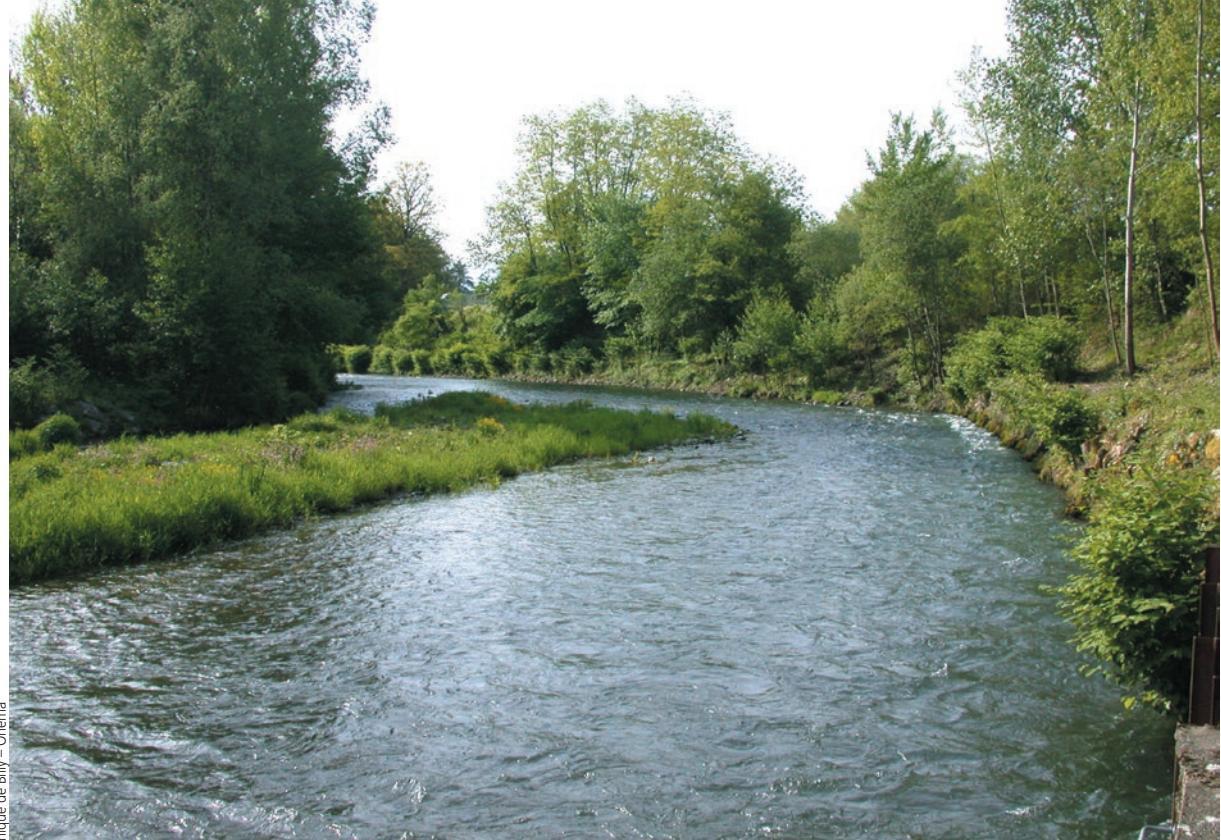
The upper Adour with a treated left bank
