# Large-flowered waterweed and Curly waterweed

## Managing large-flowered waterweed and curly waterweed by installing screens on the water bottom

### Grands Lacs intermunicipal association

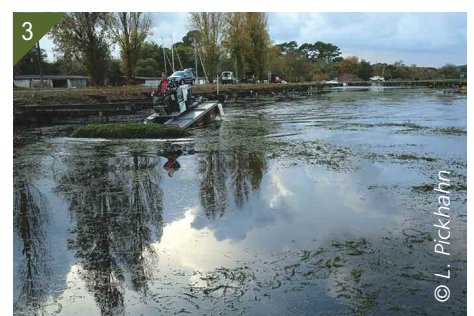
3. The Mobitrac amphibious device.

■ The device used the first year (a harvester boat that cut the plants at a depth of two metres) could scrape the bottom and remove a significant part of the root system of the plants, leaving the bottom fairly smooth. The unwieldy operation of the boat near obstacles (docks, banks) led to the decision to use a more versatile, amphibious device called the Mobitrac (see Figure 4) in 2014 and 2015. The latter was also capable of scraping the bottom thanks to a specially made tool similar to cutting bars dragged along the bottom.

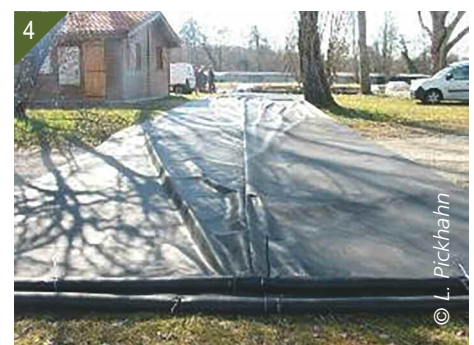
4. A screen to block light and photosynthesis.

■ The screens (Soltis part number Serge Ferrari 86-2053) are micro-perforated to enable the passage of gasses produced in the water column by fermentation in the sediment (<http://www.sergeferrari.com/protectionsolaire/gamme-protection-solaire/>).

■ A number of selection criteria determined the final choice of the product. During the bidding procedure, tests were run on the resistance to tearing, opacity and above all immersion in water. The latter criterion was decisive given the size of the screens and the technical difficulties of laying them under water.
