Water primrose

Testing a method to eradicate water primrose from two ponds in Acigné (Ille-et-Vilaine department)

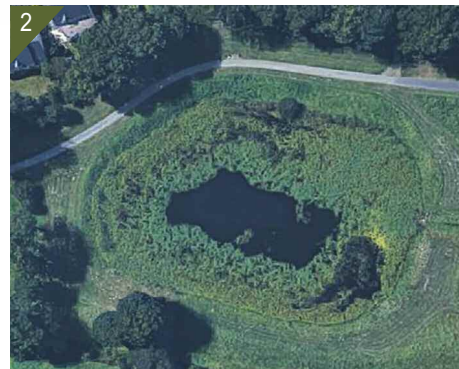
1. Maps showing the two ponds in the town of Acigné.
2. Aerial view of the buffer pond (Acigné 01).
3. Aerial view of the second pond (Acigné 02).

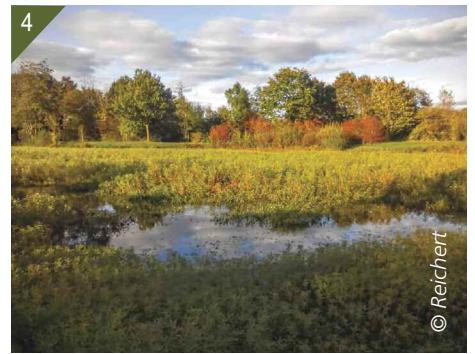
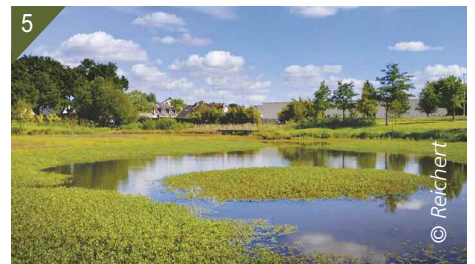
4, 5. Acigné 02 pond, prior to the work.
6. Mechanical uprooting in Acigné 02.
7. Filtering system during pumping of Acigné 02.
8, 9. Removing the surface soil in Acigné 02.

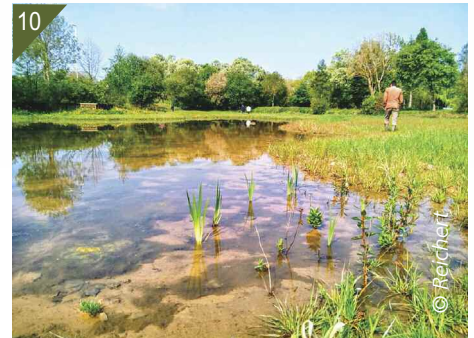
10. Reed bed in pond Acigné 02 (after the work).

- Reed beds were planted around the two ponds and meadow grasses were also sown around pond Acigné 02. Near pond Acigné 02, the plan was to preserve the reed bed to the south-east and to remove manually the water primrose growing there, but the colonisation turned out to be too extensive and the reed bed was finally removed.

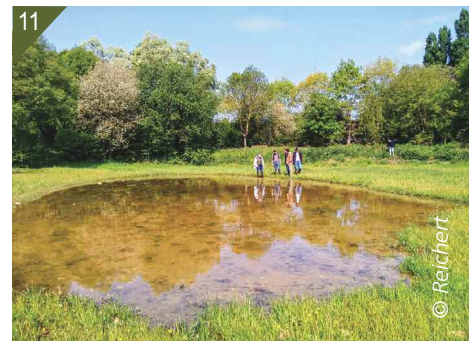
11. Pond Acigné 02 after replanting.

- Pond Acigné 02 was filled in without raising the initial topographic level in order to maintain the site as a wetland, but not a pond. The fill consisted of 50 to 70 cm of mineral soil, followed by 20 cm of top soil.
