Removal of the Stalapos weir on the Alagnon River

The operation

Category	Restoration
Type of operation	Partial or total weir/dam removal
Type of environment	Intermediate river zone
Issues at stake (water, biodiversity, climate)	River continuity

Start of operation	June 2008
End of operation	November 2009
Length of river affected by the works	400 m

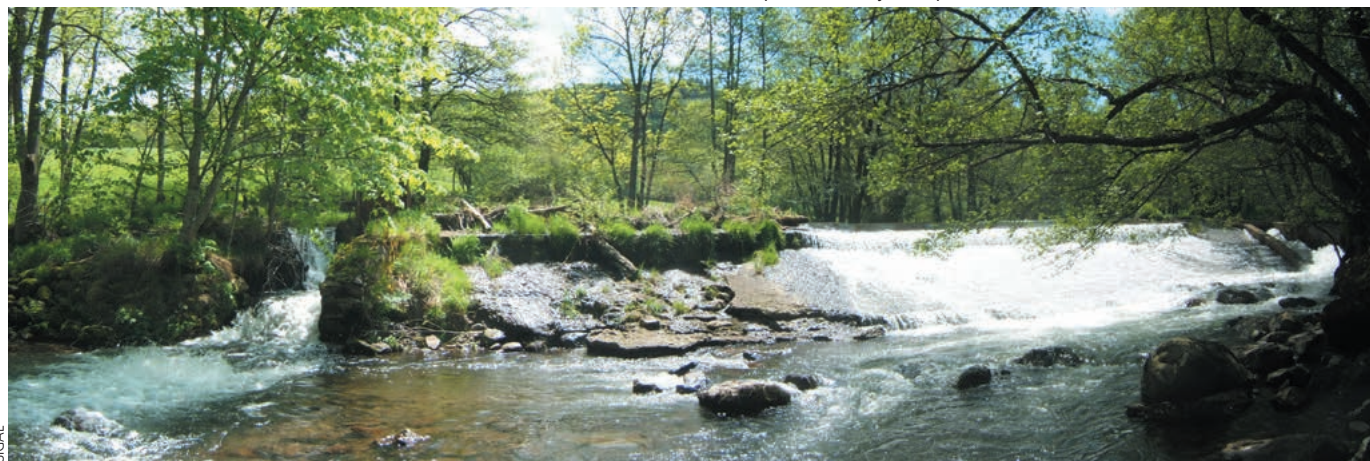
The Stalapos weir in May 2008, prior to the works.

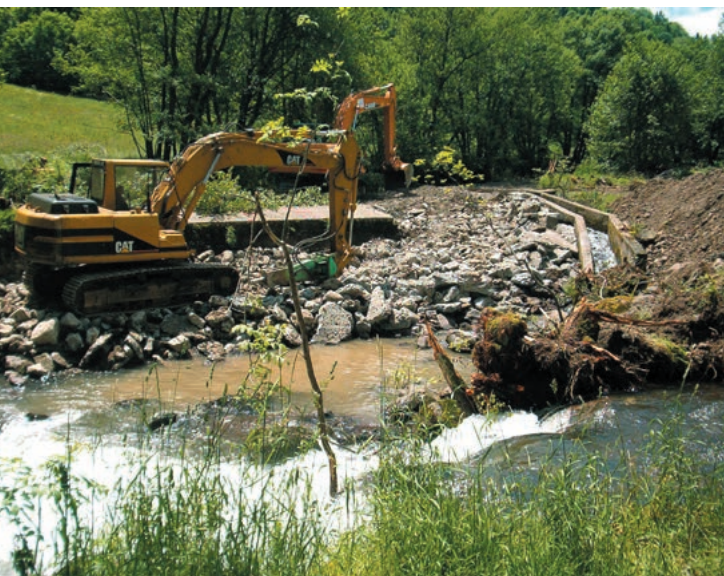
Removal of the Stalapos weir during the excavation phase of the project in June 2008. The river was diverted to dewater the weir and the impounded reach.

Prior to the actual work, the river was diverted to dewater the weir and the impounded reach. In June and July 2008, the weir was removed by an excavator. The river bed was then graded and stone banking was installed to prevent erosion along the camp ground. The slope of the banks was reworked, trees planted and the site was completely replanted in November 2009.

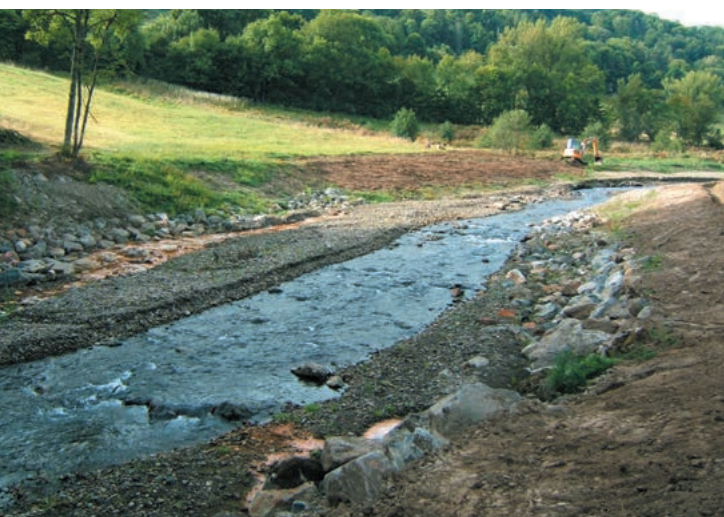
The work done upstream of the weir in 2008.

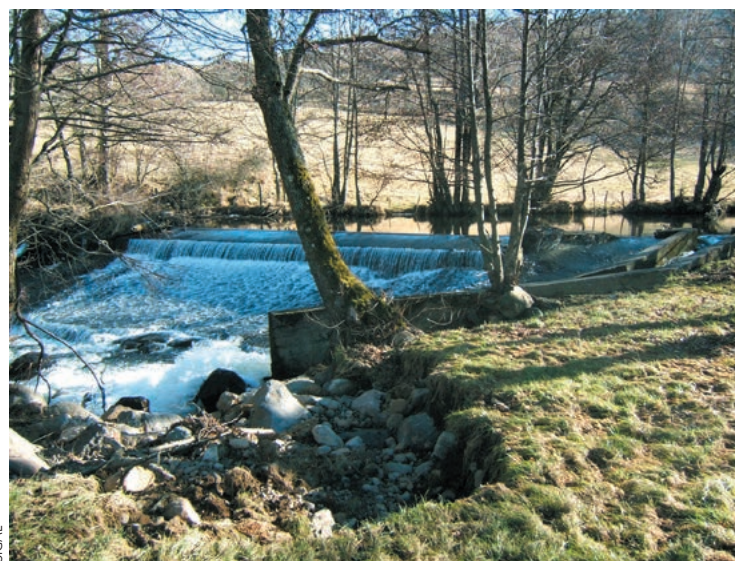
View of the weir before its removal.

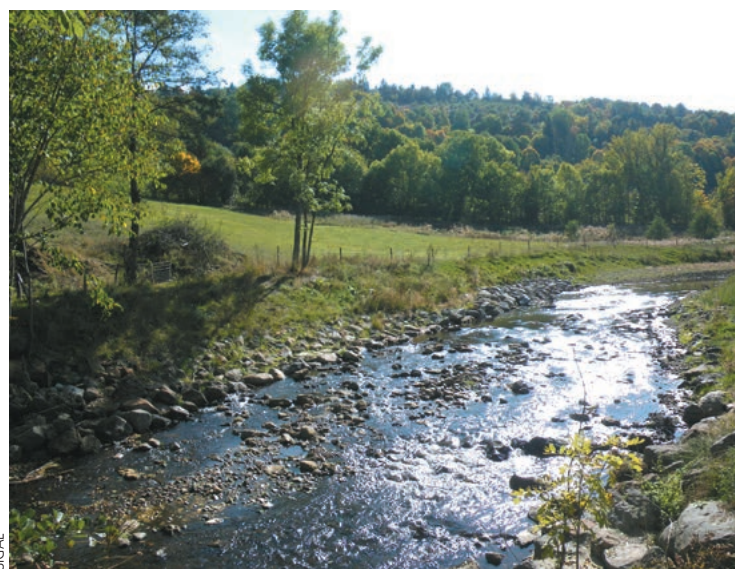
View after removal of the weir in November 2009, the vegetation has partially grown back and the river bed is more diverse.

Immediately following the removal of the weir in 2009, morphological adjustments were observed. In the work zone where the weir once stood, the river bed dropped 1.1 metres and would appear to have reached the point of equilibrium. Measurements carried out in 2011 and 2014 confirmed these results. For the river reach as a whole, the long profile stabilised, with local dips and rises in the river bed balancing out.

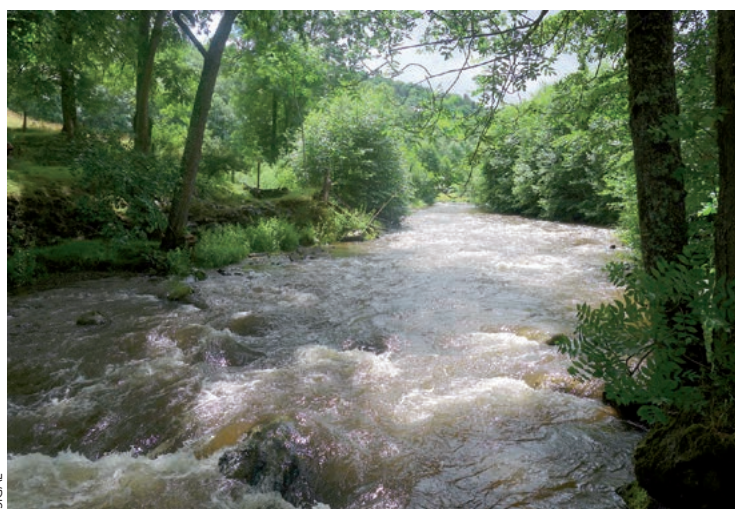
View of the site in 2017, nine years after the works
