## MEUSE RIVER

| <b>Title</b> | <b>THE RIVER RESTORATION PROJECT OF THE BORDER MEUSE</b> |
| <b>Organization</b> | <b>WWFs Ark Nature organisation, River Park Meuse Valley</b> |
| <b>River typology</b> | Meandering large gravel river |

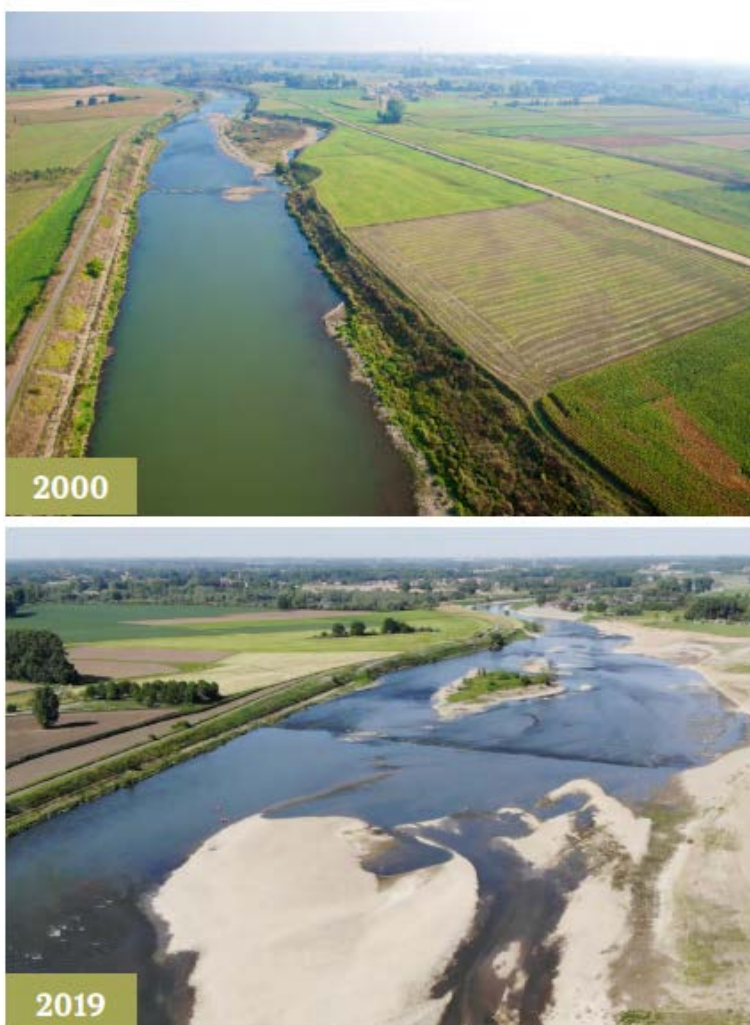
Figure 4. Before and after the widening of the river channel (Source: maasinbeeld.nl).

The river has been widened broadening the stream channel, lowering the floodplain and storage of floodplain top soils in clay shields to protect the groundwater levels. The river itself broadened with banks of sand and gravel, side arms, varied shorelines, and areas of grassland and woodland. This has created a dynamic, braided river landscape that is allowed to flood and shift course naturally (European Rewilding Network) (Figure 4).

The project's implementation is executed from upstream to downstream. The river widening is carried out through a combination of broadening the stream channel, lowering the floodplain and storage of floodplain top soils in clay shields to protect the groundwater levels. Together with unexcavated parts, thirteen cross-border sub-areas make up the Border Meuse project.

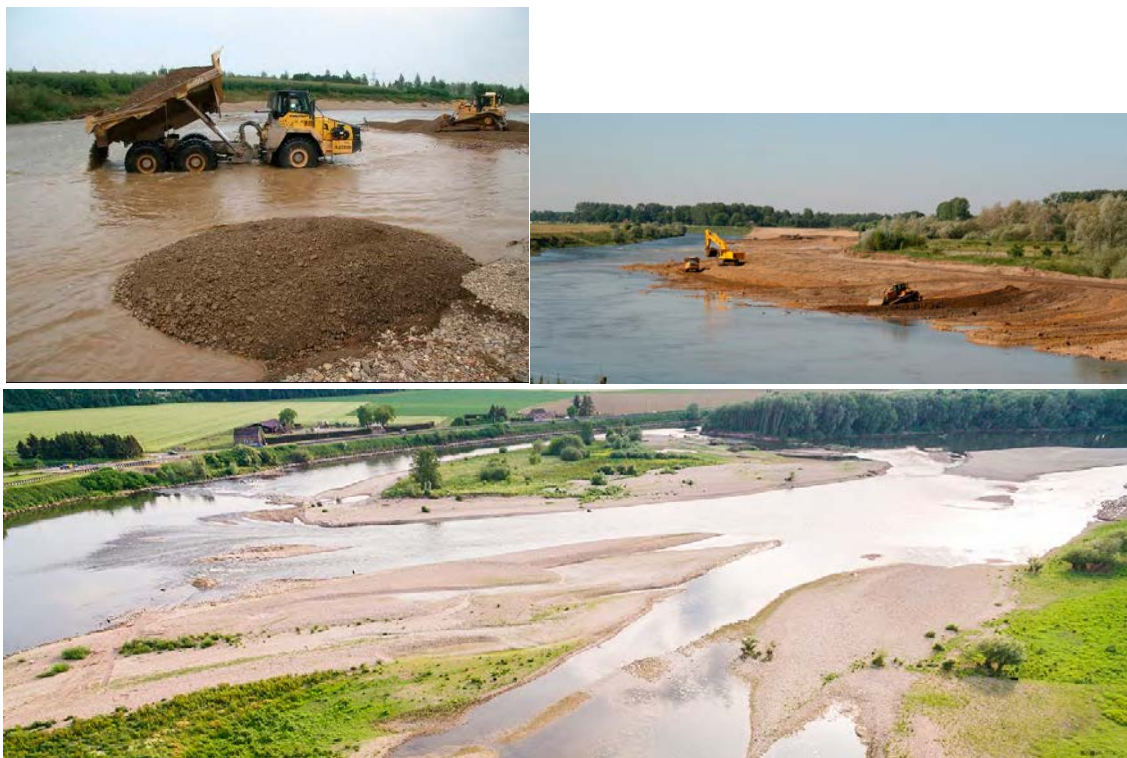
Figure 5. Gravel augmentation, lowering of banks and gravel pit recovering on the Flemish area in 2009  
(Source: maasinbeeld.nl).

400,000 m<sup>3</sup> of gravel was added lowering the floodplain and river banks. *“The existing gravel pits were integrated into the river system by lowering the banks and guiding the floods through channels and levees”* (maasinbeeld.nl).

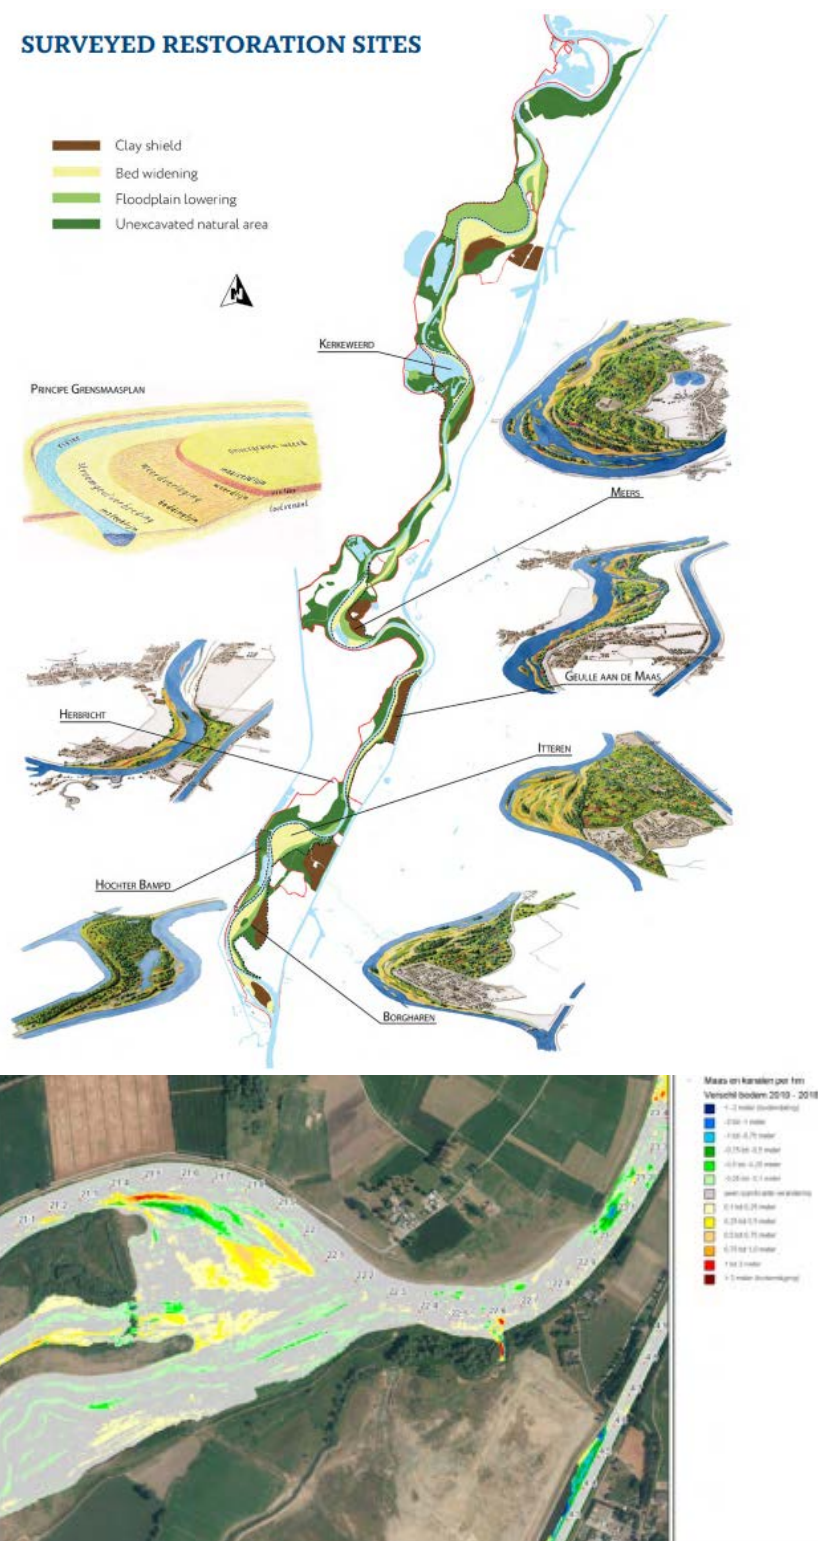
Figure 6. Location of the monitoring sites and hydromorphological monitoring (Source: maasinbeeld.nl).

An extensive ecological monitoring programme was developed in cooperation among more than ten partners from the Netherlands and Flanders. The study focused on the restored natural areas in the southern part of the River Park, which have been created with riverbed widening and floodplain lowering (Figure 6).

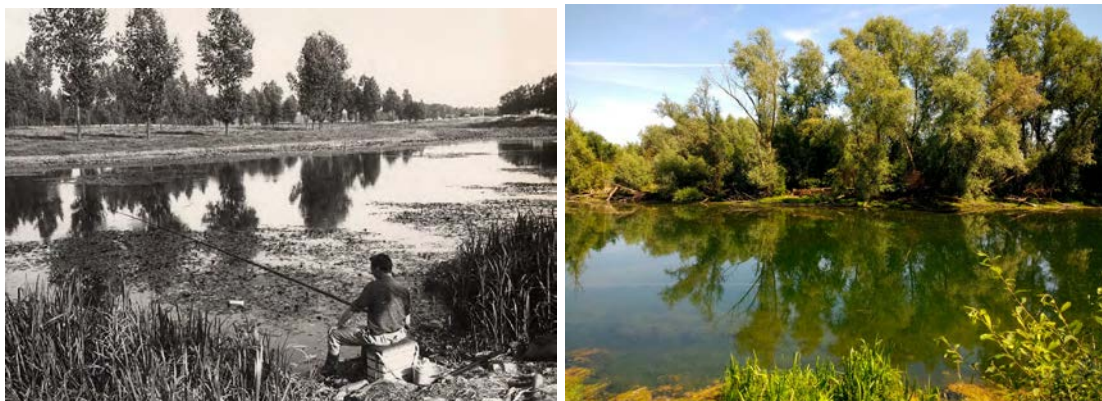
Figure 6. Same location 50 years ago and nowadays (Source: maasinbeeld.nl).

The restoration of the river has given clear results of the geomorphological and ecological recovery of the river (Figure 6).
