# Reopening of the culverted Redon river

## The operation

Category	Restoration
Type of operation	Reopening of a culverted watercourse
Type of environment	Lowland watercourse
Issues at stake (water, biodiversity, climate)	River continuity
Start of operation	September 2006
End of operation	January 2007
Length of river affected by the works	230 m

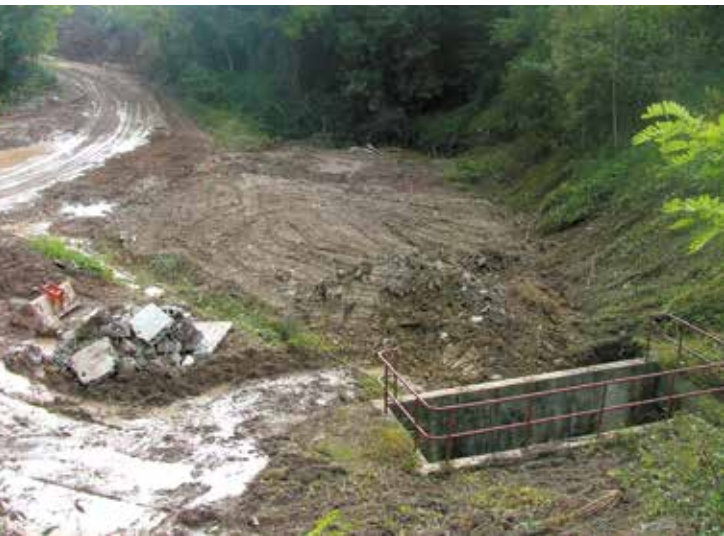
The Redon buried in the downstream section. Before restoration work -2007.

230 metres of the culverted river were reopened. In order to diversify the environment, a meandering bed was created. Plantation was used to protect the banks and the longitudinal section was stabilised.

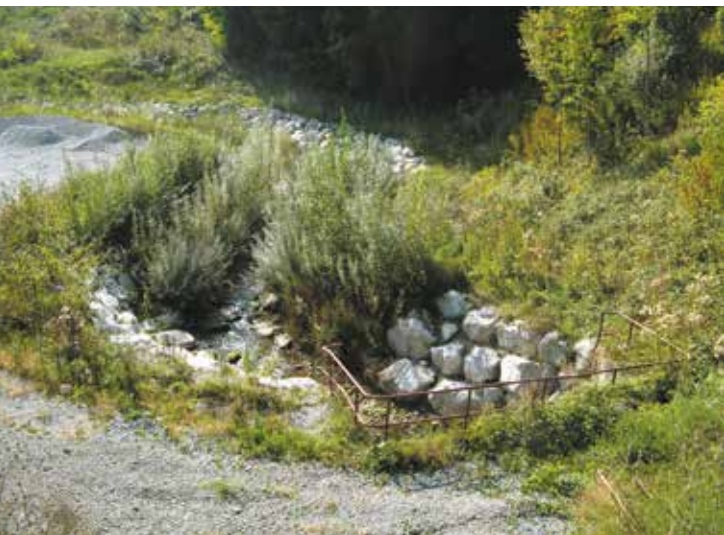
The Redon in the downstream section, 2 years after restoration work - 2009.

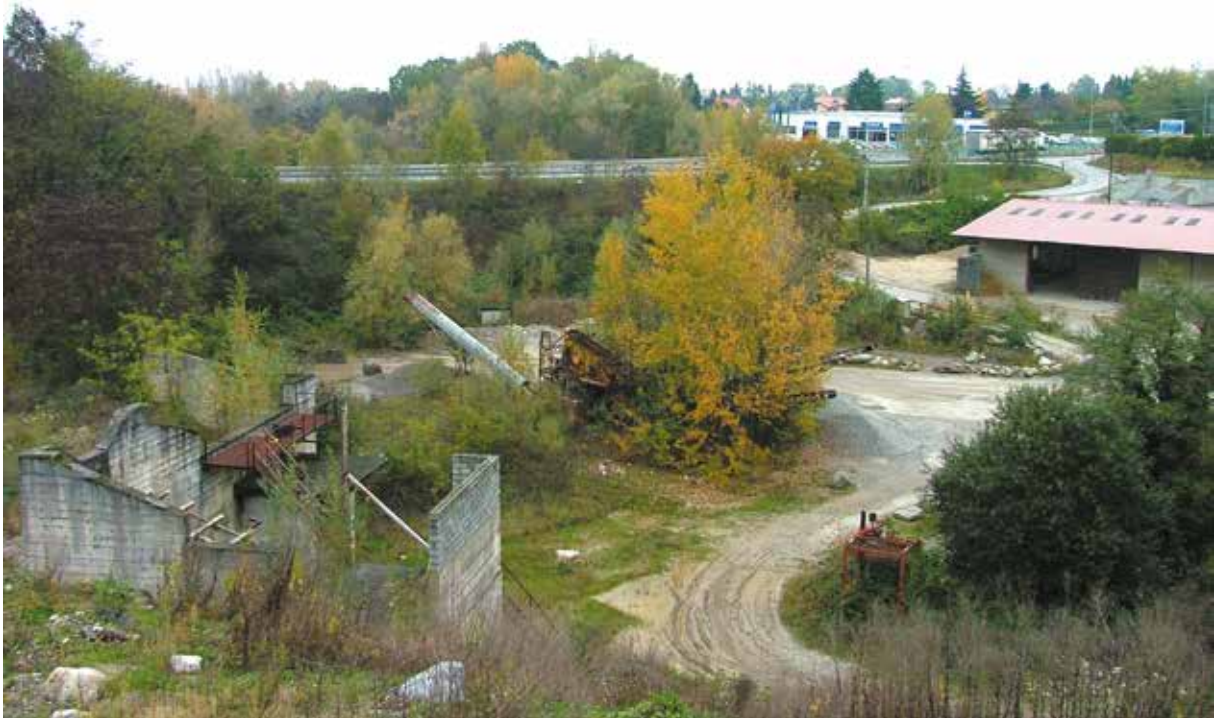
Overview of the quarry before restoration work - 2007.

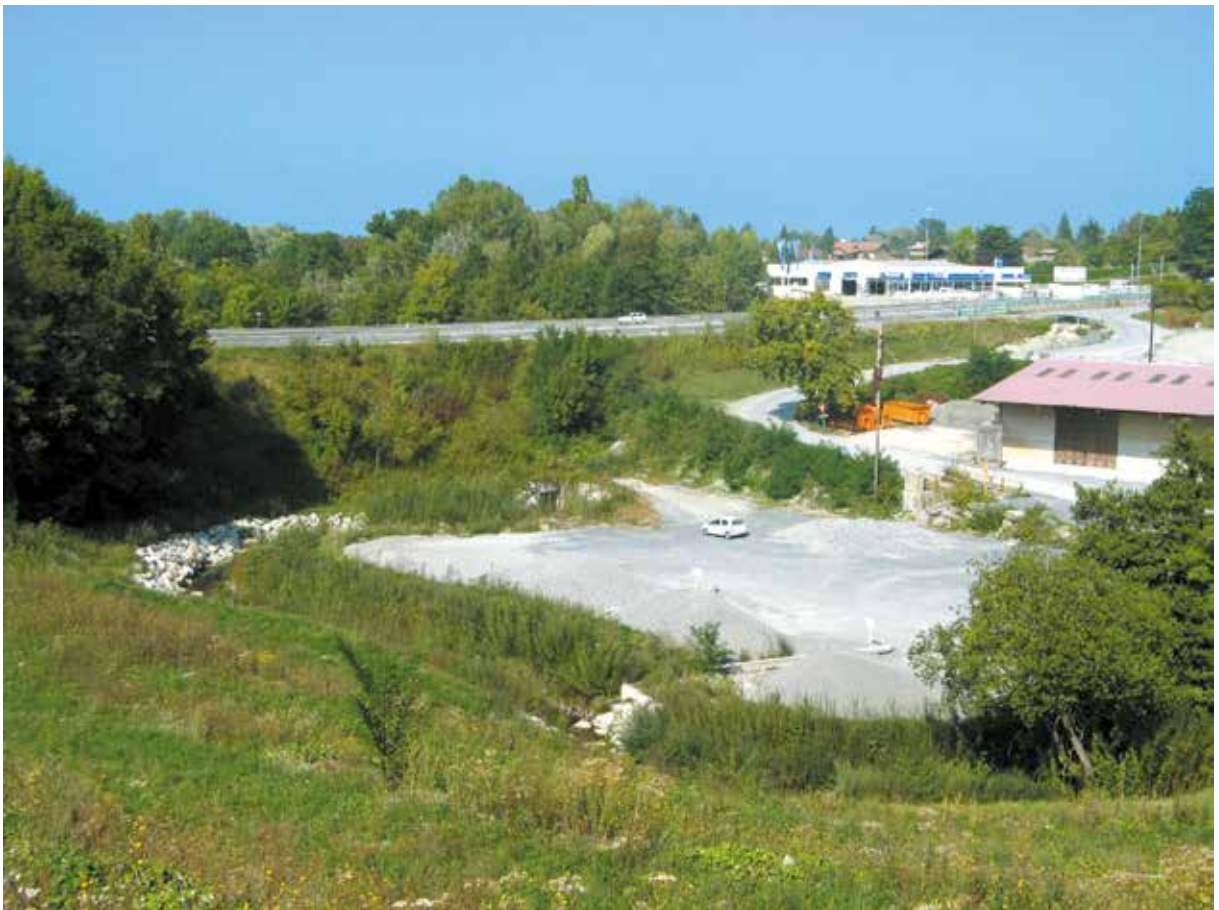
Reopening of 230 metres of the Redon. Overview of the site after restoration work - 2009.

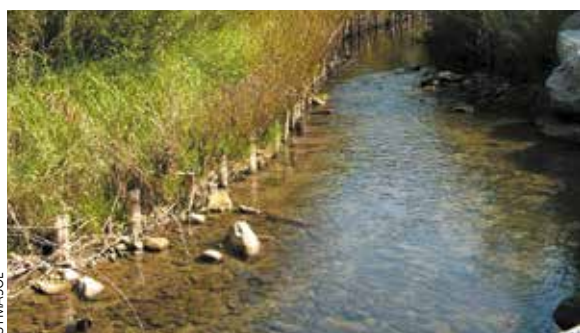
The Redon after the reopening and development of the low water channel - 2009.
